MiCHe project

UNIBO UNIT CONTRIBUTION

Case study: Modena Cathedral

Mitigating the Impacts of natural hazards on Cultural Heritage
sites, structures and artefacts

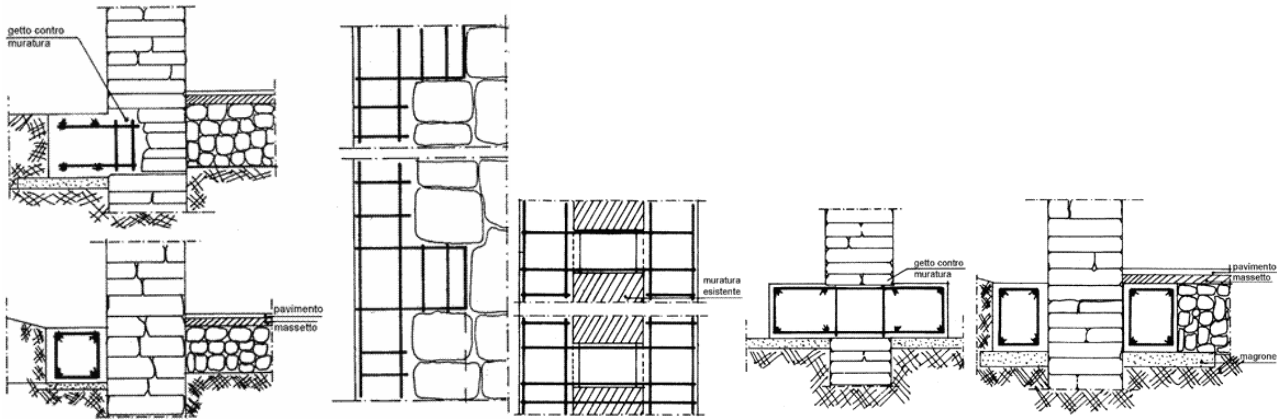
Figure 1.4.2: footing increasing by one side and both sides.

enlarging the foundation only on the external side, or when possible the foundation can be extended on both sides (internal and external), see Figure 1.4.1.

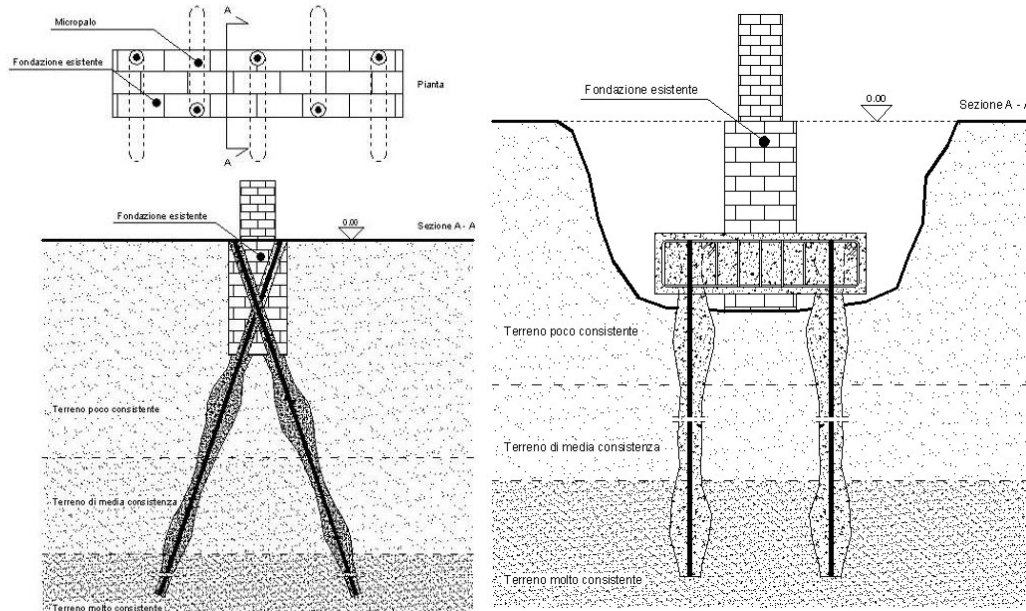
Figure 1.4.4: underpinning with micro-piles.

Underpinning with micropiles is an intervention that allows a direct improvement of existing foundation for example crossing them or with realization of two concrete footing beams. As it can be noted in Figure 1.4.3 a, micropiles go through the existing masonry wall and several layers of soil in

order to reach the one with adequate consistency. In figure 2.11, micropiles are used together with the simultaneous enlargement of the base section of the foundation.

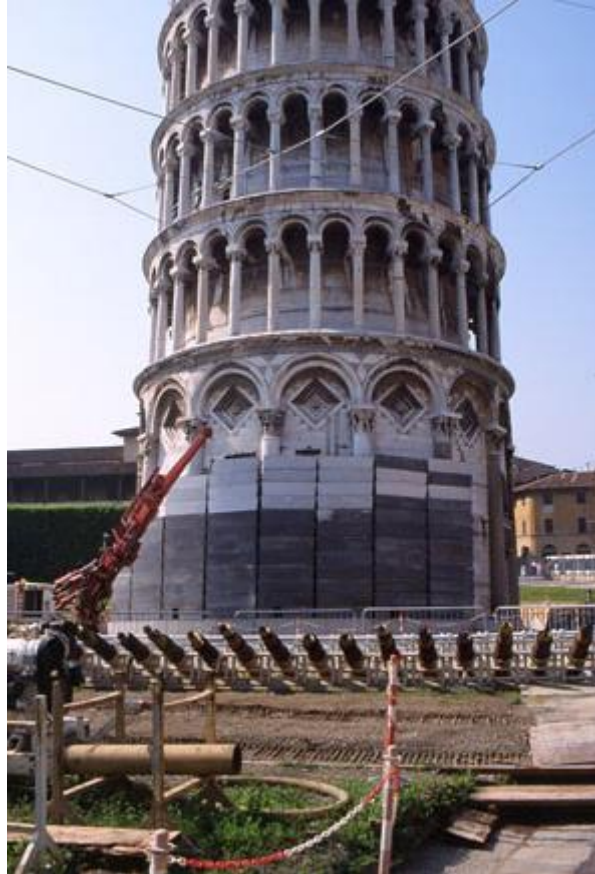
Figure 1.4.6: Under-excavation work and tensioned cables

A soil extraction intervention was performed during years 1999-2001 involved the removal of small soil volumes from underneath the elevated part of the foundation. First of all cables were attached around third storey and tensioned to stabilise the Tower during drilling. Then drill were inserted at shallow angle to extract small volumes of soil on the North side of the Tower, in this way cavity fills under pressure of Tower, slowly reversing its southward tilt.

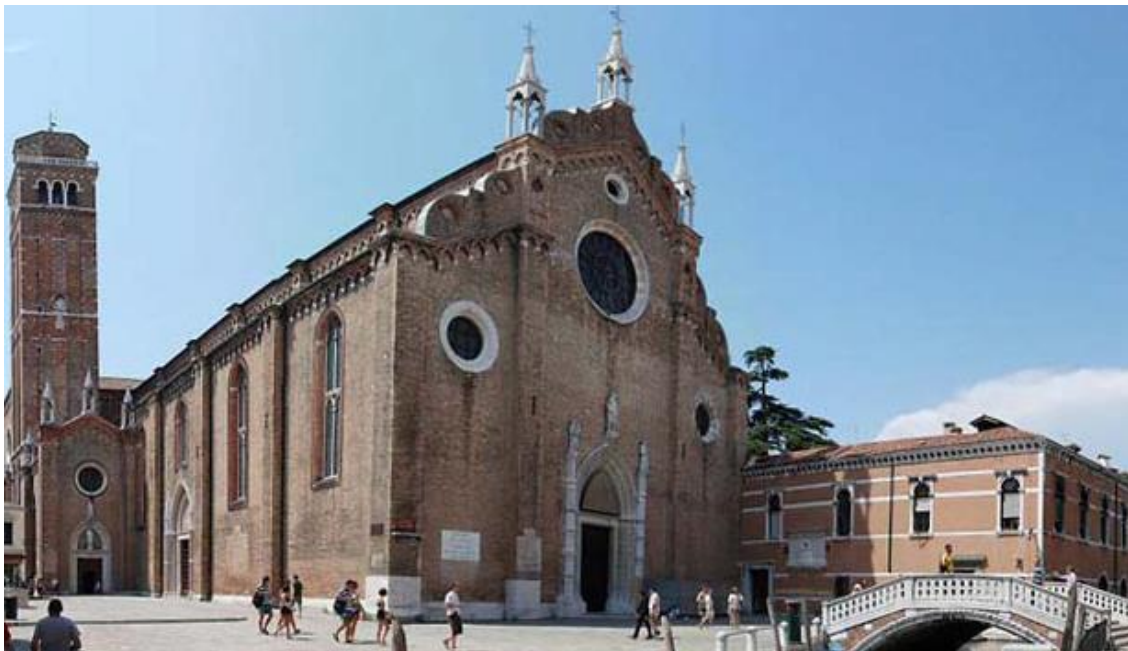
Figure 1.4.7: Santa Maria Gloriosa dei Frari church and adjacent bell tower

The Basilica of Santa Maria Gloriosa dei Frari was built in Venice between the first half of the XIV and the second half of XV century. The adjacent Frari bell tower is the second tallest in the city after that of San Marco with a high of 65m. Originally the bell tower was conceived as a fully independent structure, but during the reconstruction of the Basilica, the bell tower was included into the masonry walls, at the south-east corner of transept and left aisle. The connection between the bell tower and the Basilica is at the origin of the subsequent problems that have always affected their structures. The bell tower showed the first documented signs of movements at the end of the XVI century [10]. Its movements (settlement and tilting) continued progressively and at the end of 19th century it was observed a differential settlement of about 40 cm between the bell-tower and the walls of the Basilica. At that time, the deviation from verticality, measured at a height of 42.50 m, was about 76.50 cm toward outside.

To reduce the differential settlements of the bell tower, an innovative intervention of careful soil fracturing, also known as fracture grouting, was designed, in order to improve the mechanical characteristics of the soft silty clay.

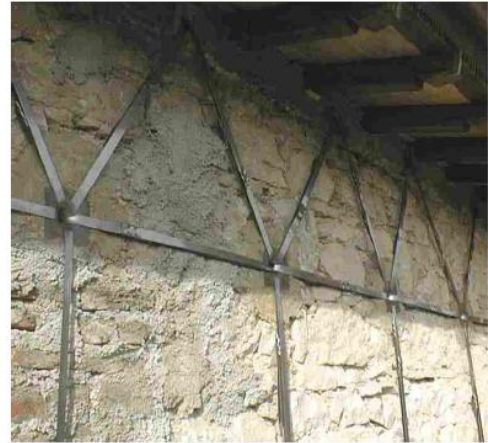
Figure 1.4.9: CAM arrangement in the façade [20]

The CAM system does not use bars to create ties: it consists of steel ribbons that form horizontal and vertical loops, passing through transverse holes. The flexibility of the system allows rectangular, rhombic, triangular, and irregular arrangements of the mesh.

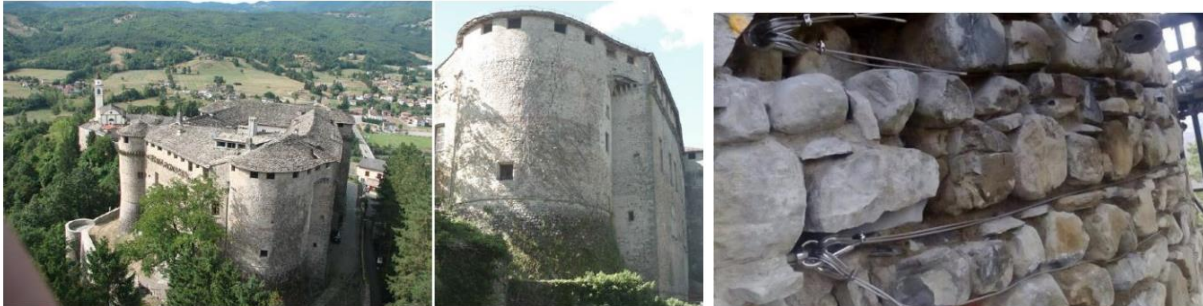
Figure 1.4.10: Application of Reticulatus technique to the Castle of Compiano [22]

More in detail, it consists in insertion of a continuous mesh made from high strength steel or composite cords in the mortar joints, stripped to a depth of 40-60 mm. The cords are arranged in vertical and horizontal directions, forming approximately square meshes, the dimensions of which, normally 300-500 mm wide, depend on the size of the stones in the masonry, and, as a rule, must not be greater than the thickness of the wall. The cords are connected to the transverse bars by means of eyelets in which the cords can slide: thus it is possible to apply a moderate tension, so as to make the mesh immediately functional. When the size of the stone walling material is such as to prevent the use of bars passing through the entire thickness of the masonry, the connection can be made with bars about 2/3 as long as the thickness of the wall, anchored with the injecting of non-shrink mortar or epoxy resin. With the aim at connecting the cord-reinforcement to the existing masonry and at increasing the level of connection between masonry wall leaves, it is advised to use an epoxy mortar, but when this is not possible a non shrink cement-based mortar could be also used. The final application of mortar, which completely covers both the cords and the heads of the transverse bars, makes it possible to preserve the fair-faced aspect of the masonry. All used mortars were lime-based, specifically designed for use with historic masonry. Because many historic buildings are restricted by protection and heritage conservation authorities, which in many cases do not authorize an extensive use of the repointing technique, the requirement for reversible

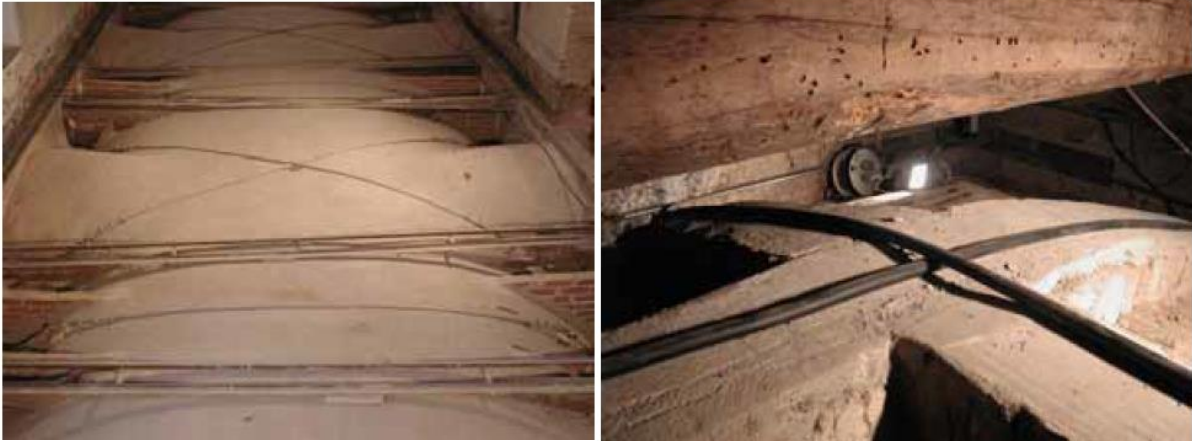
Figure 1.4.11: Application of “reinforced arch method” to the vaults of Casa Giacobbe (Milan) and Manta Castle (Cuneo) [26].

Jurina [26] developed a techniques called “reinforced arch methods” to strength arches and vaults. The consolidation consist on placing cables alongside the extrados of arches and vaults providing strength whit minimum increase of mass. The cables are fixed to the masonry of the supporting walls

and then post-tensioned. The “reinforced arch method” has been applied for the conservation of several structures.

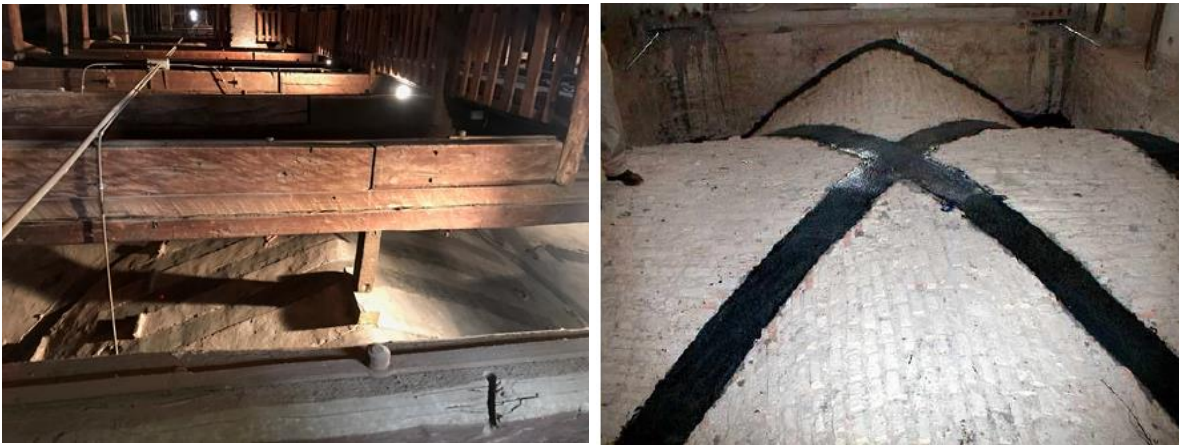
Figure 1.4.12: Application of FRP strips on the vaults of San Petronio church in Bologna and town hall of Assisi.

The application of fibre reinforced polymers (FRP) for strengthening of masonry structures is very beneficial thanks to its easy installation, low self-weight that does not alter the mass of the structure, high strength, ability to preserve the initial geometrical configuration and reversibility. The FRP techniques have been widely used in recent years for the consolidation of arches and masonry vaults, especially inside to monumental buildings, i.e FRP strips have been used to strength the vaults of the town hall of Assisi, the San Barnaba church in Modena [36], [37], the San Petronio church in Bologna)

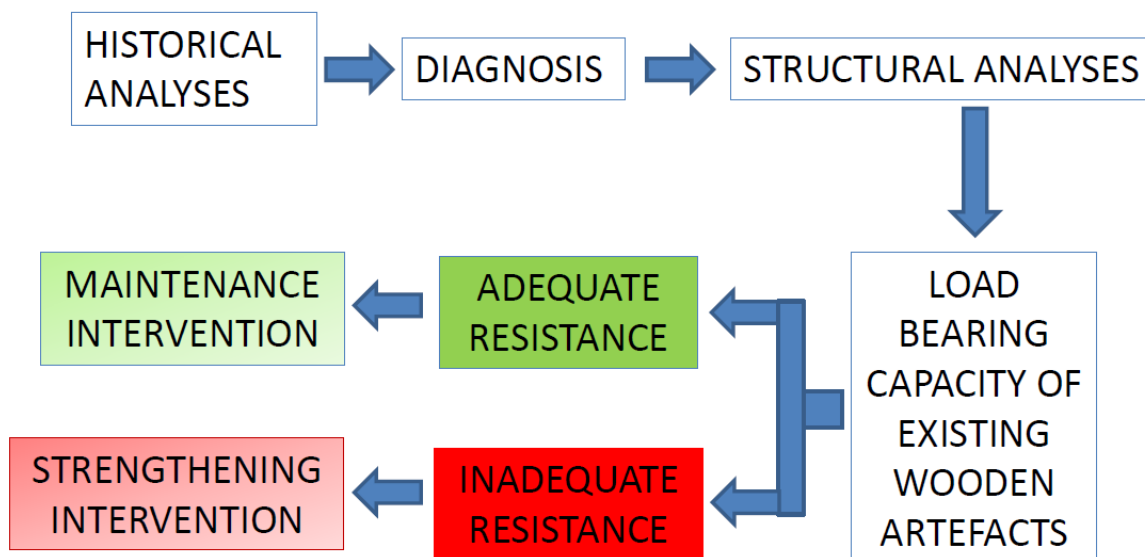
Figure 1.4.13: flow-chart-approach for roof strengthening

- historical analyses (past interventions, failure, occurred damages, etc.);
- material characterization (according to UNI 11118 and UNI 11119);
- geometrical characterization;
- damage diagnosis;
- structural analysis (the reliability of the structural analysis depends on the accuracy of the previous steps).

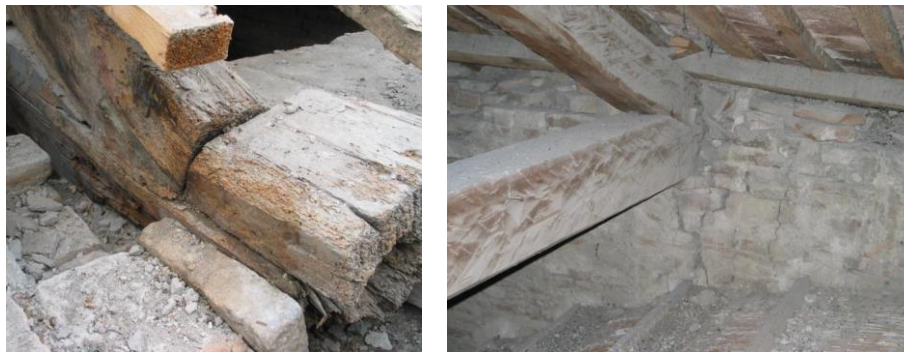
Figure 1.4.16: details of the roof system.

Looking at the wooden roof structure, it's observed that the trusses have undergone an out of plane movement, there are cracks in the walls near the heads of the wooden beams, portions of damaged beams and the roof is not effectively connected to the bearing walls.

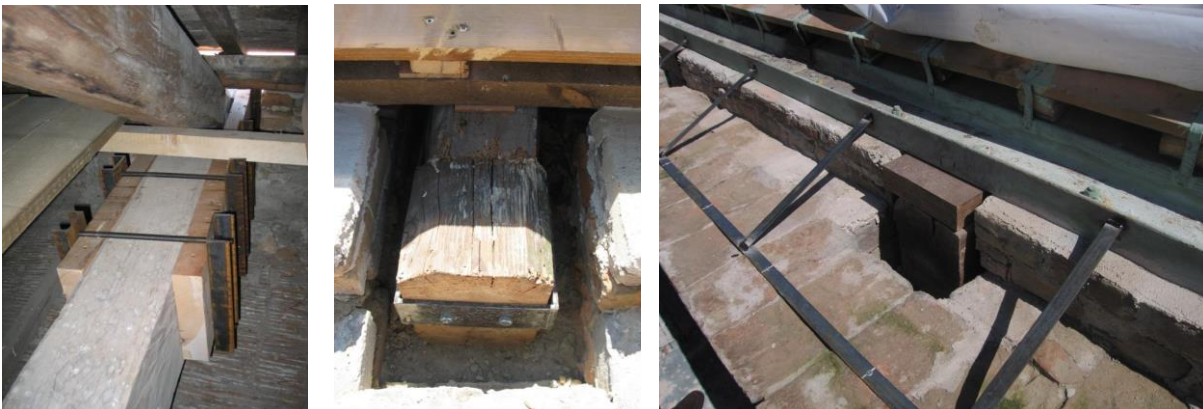
Figure 1.4.18: Details about the interventions

To mitigate the critical issues described it's necessary to perform the following procedures:

- checking the state of degradation of the wooden trusses and perform the restoration of the damaged portions;
- checking the possible presence of mold, insects and pests etc. and select the specific treatment to avoid them;

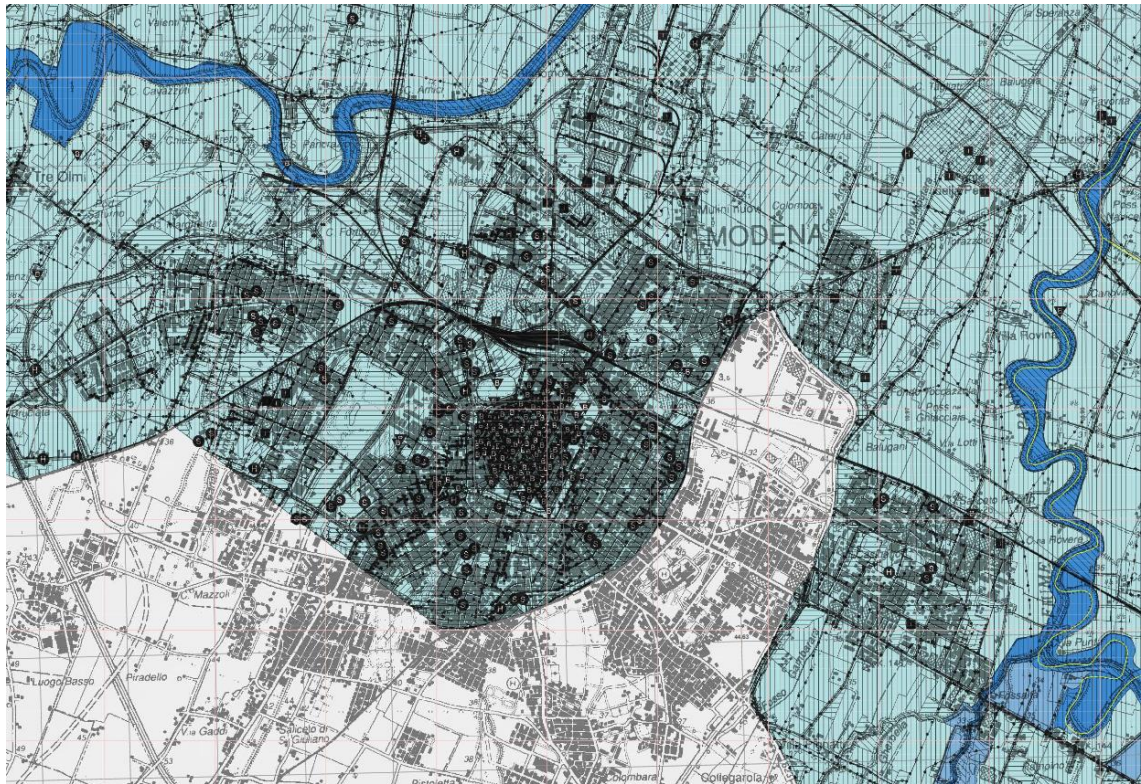
Figure 1.5.1 – Flood hazard map for the city of Modena

Flood hazard maps for the city of Modena are available in the Flood Risk Assessment Plan for the Po River Basin in panel “RP_RSCM_Tavola_201SE”. An extract is reported in Figure 1.5.1, which shows that the city of Modena, and particularly the Cathedral area presents a low probability to be flooded (i.e. return period equal to 500 years).

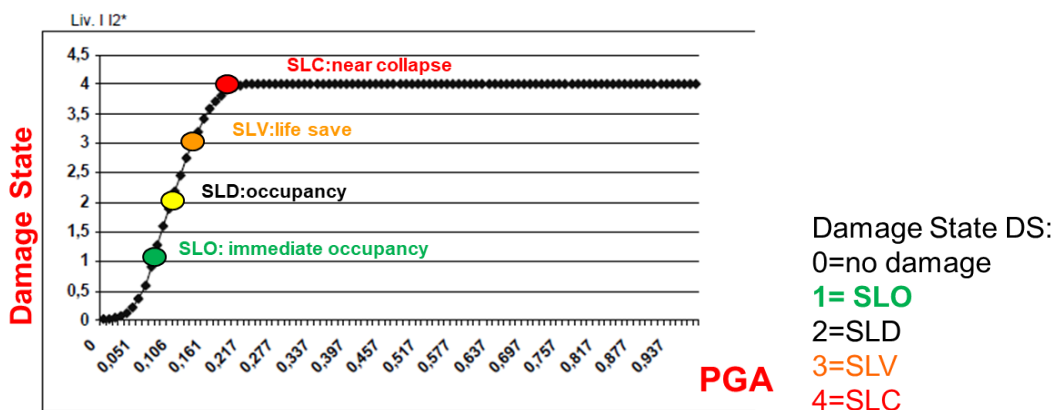
Figure 1.6.4 – Example of performance curve.

The structural damage index, with specific reference to the seismic case, takes values from **0 (no damage to the structure) up to 4 (total damage to the structure)**. The damage index values have been defined in relation to the 4 structural performance levels on which the Performance Based Design procedures are structured (SLO, SLD, SLV, SLC).

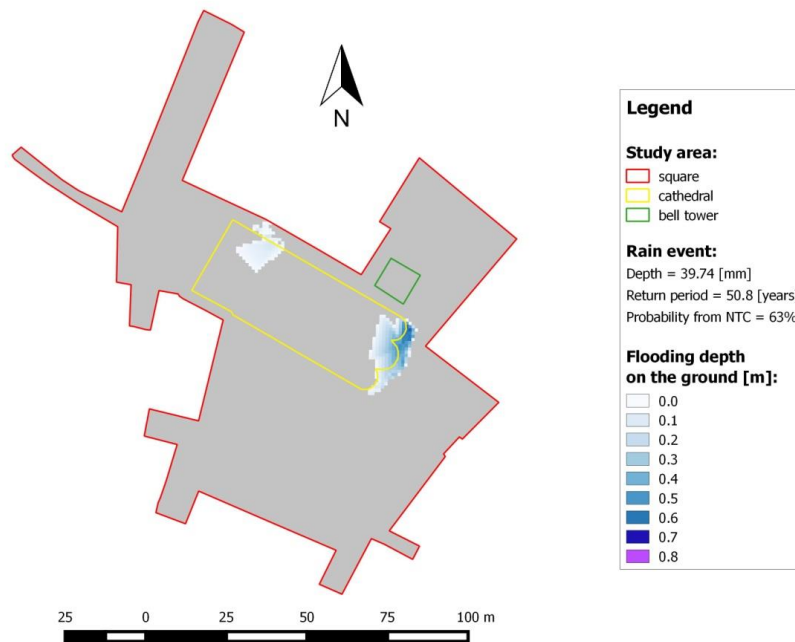
Figure 2.1.22- Maximum flooding depth on the ground for a precipitation depth equal to 39.74 mm.

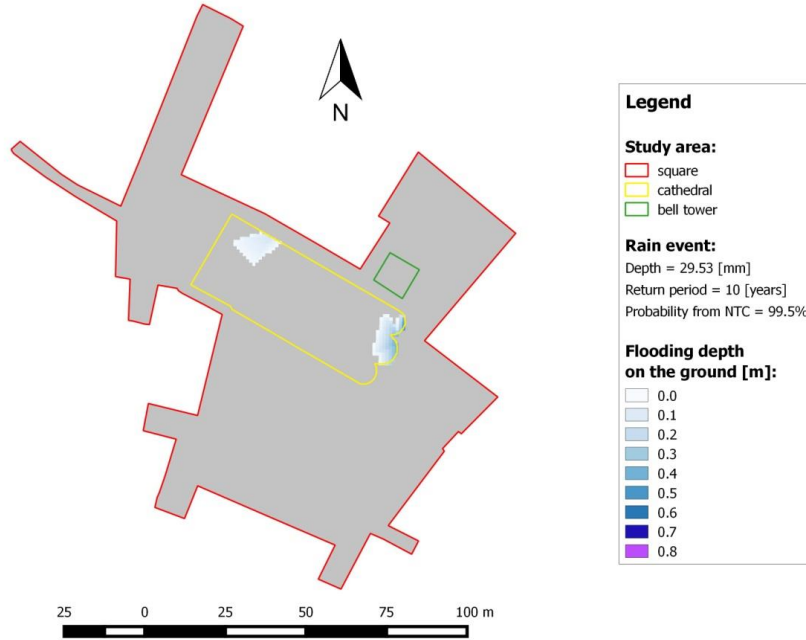
Figure 2.1.25 - Maximum flooding depth on the ground for a precipitation depth equal to 29.53 mm.

Figure 2.1.25 shows the maximum flooding depths [m] for a rainfall event with a depth equal to 29.53 mm and a return period of 10 years. As represented in the image, in the 80% of cases, the flooding depths on the ground are in the range 0 – 26.1 cm. The average flooding depth on the ground is 11.8 cm. Only locally, in topographically depressed areas, these depths can reach values 49.1 cm.

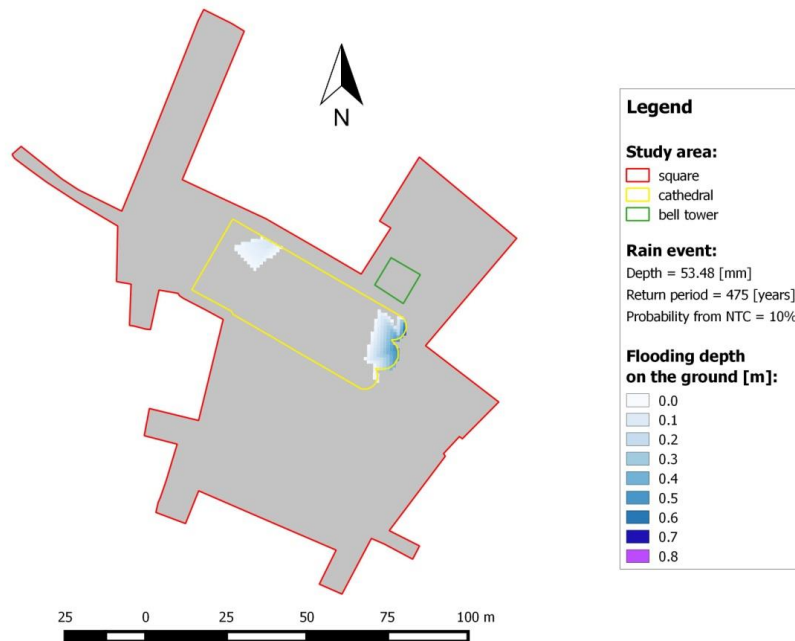
Figure 2.1.28 - Maximum flooding depth on the ground for a precipitation depth equal to 53.48 mm.

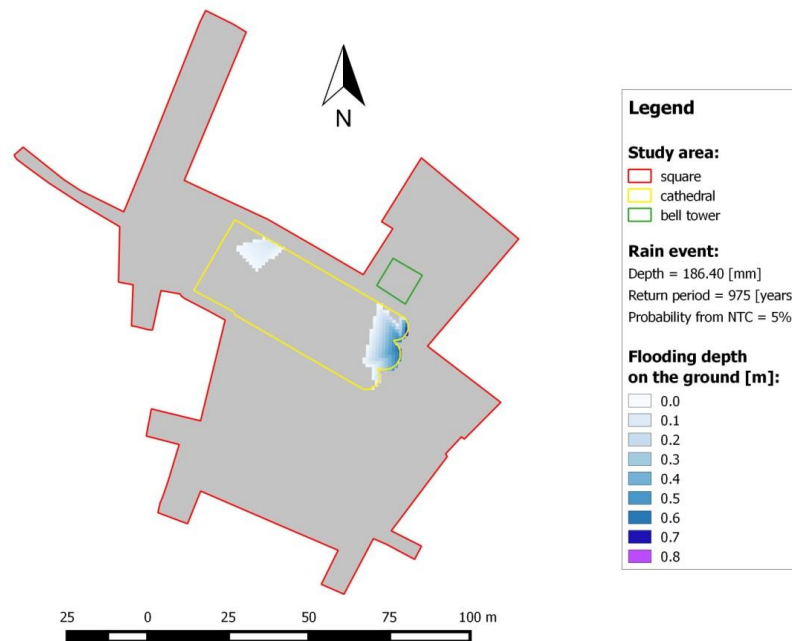
Figure 2.1.29 - Maximum flooding depth on the ground for a precipitation depth equal to 186.40 mm.

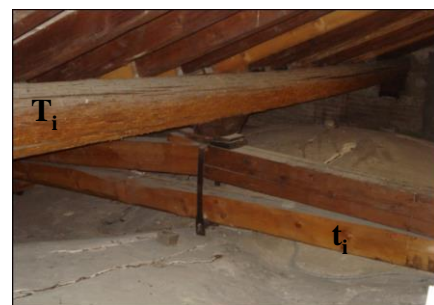
Figure 2.2.2: a) A 3D view of the roof system; b) Structural roof elements and c) Main beams (T_i) and trusses system (t_i)

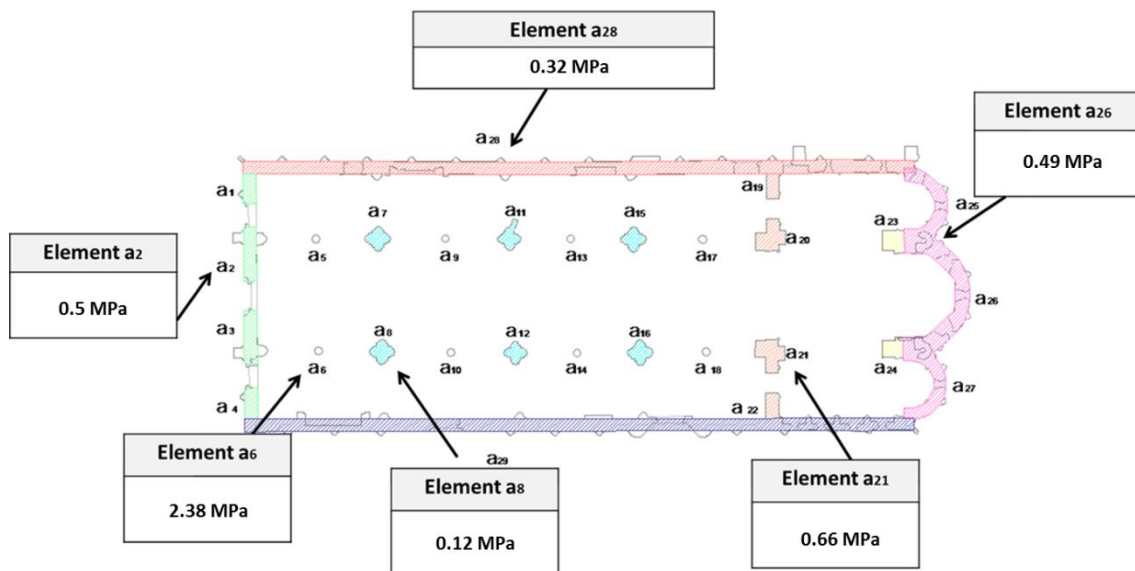
Figure 2.2.4: Reference values of the stress level at the base of the principal structural elements.

The hand-made schematizations of the single walls are used to calculate the stresses at the wall base, according to the Navier - de Saint Venant formulation, due to the self-weight, the weight of the vaults and the reactions of the roof system. In detail, the following assumptions have been made: (i) two limiting conditions: full cross-section and hollow cross-section (or “a sacco”, i.e. two exterior masonry layers plus an interior layer composed of chaotic stones and filling materials; in the “a-sacco” configuration the wall inertia is equal to the inertia of the two exterior layers only); (ii) constant wall thickness equal to the average wall thickness; (iii) the presence of decorative elements has been neglected; (iv) each wall has been subdivided into homogeneous portions (i.e. same cross-section, referred to as a_i , $i=1, \dots, 28$) for the evaluation of the normal average stresses at the base, (iv) perfect verticality of the masonry walls. In the limiting case of full cross-section, the normal stresses due to the gravity loads are between 0.3 and 0.8 MPa for exterior walls and between 1 and 1.4 MPa for masonry piers. On the other hand, in the limiting case of hollow cross-section (“a sacco” masonry), the normal stresses due to the gravity loads double both for the external walls and the internal piers. The maximum stress at the base of the stone columns is around 3.2 MPa. The increase due to the snow load is about 2.5% of the stresses due to gravity load. These stresses levels at the walls base obtained from simple hand-made models (Figure 2.2.4) have then been compared with those obtained from the 2D FE models, which are reported in terms of contour maps in Figure 2.2.5. This comparison indicates a good agreement between the two analyses.

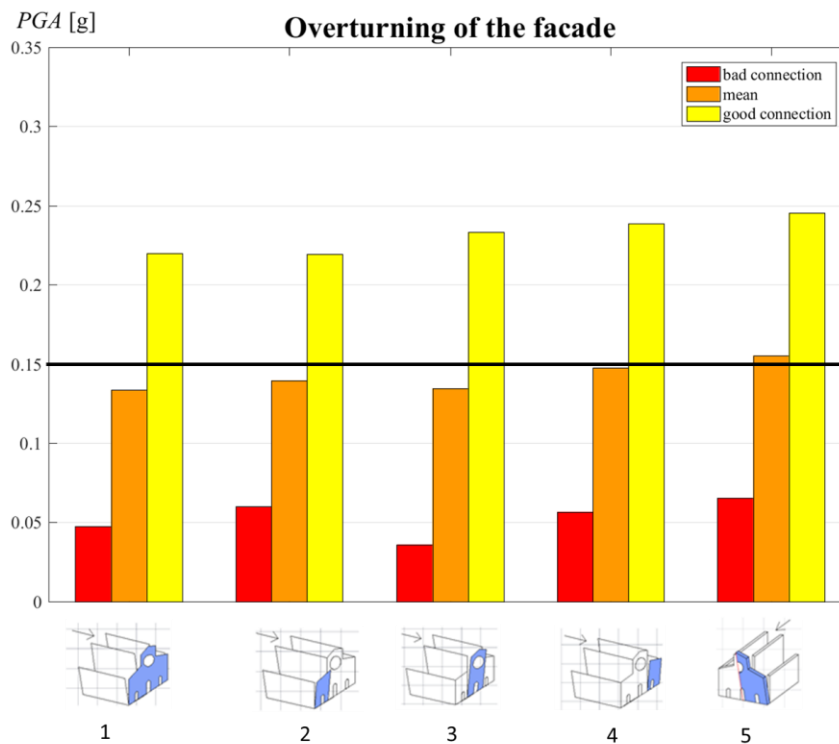
Figure 2.2.24: Comparison between the accelerations that activate the 4 mechanisms of collapse for the façade

Figure 2.2.24 shows the acceleration values that activate overturning mechanisms of the different portions of the façade for the different connection considered. These values, also considering the good connection, are higher than the acceleration reference values for the past earthquakes obtained from HDSHA §1.3.1 (0.15-0.20 g), but lower than the acceleration estimates for the possible future earthquakes obtained from MHEA §1.3.2 (0.50 g).

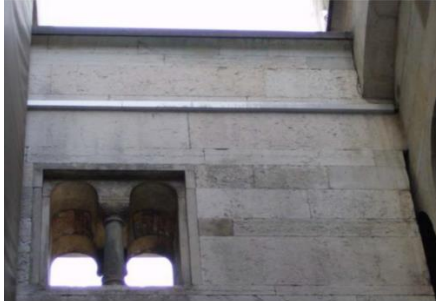
Figure 2.2.39: Deformer installed on the buttress of the Cathedral (D1)

The deformeters were placed on the buttresses between the Cathedral and the Ghirlandina Tower (Figure 2.2.39). They are designed to perform the deflection measurements of a structure of a substantial amount (in this case have an overall length of 5 meters). They consist of Invar rods having a low coefficient of thermal expansion. On the wall of the Ghirlandina tower was put the anchor support, while on the Cathedral wall is anchored to a non-contact sensor of the inductive type with 8 mm theoretical measurement range with a resolution of 0.01 mm. They are fed to a continuous voltage of 24 Vdc and the analog output signal is between 4 and 20 mA proportional to the distance between the transducer and the target. Conventionally the positive values on the graphs, which will be explained later, correspond to an estrangement between the Tower and the Cathedral, while negative values correspond to a rapprochement of the two.

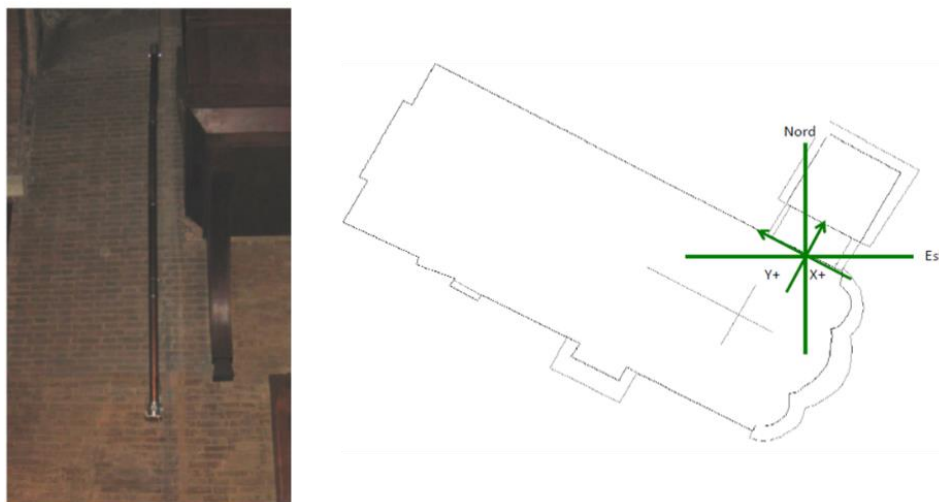
Figure 2.2.42: Inclinometer installed on the longitudinal wall of the cathedral (close to the buttress) FP1 and the conventional signs used.

The inclinometers (or pendulums) installed on the cathedral are designed for the control of the stability of the buildings, and their operation is based on the principle of a plumb line (Figure 2.2.42). It consists of: an upper berth, to the plumb bob (consists of Invar alloy to contain the thermal expansions), and the measuring instrument (that allows to perform the automatic measurement of the plumb line portion). This data allow analysing the slope changes of the Cathedral, both periodic (due to temperature variations) and permanent ones due to real structural behaviour.

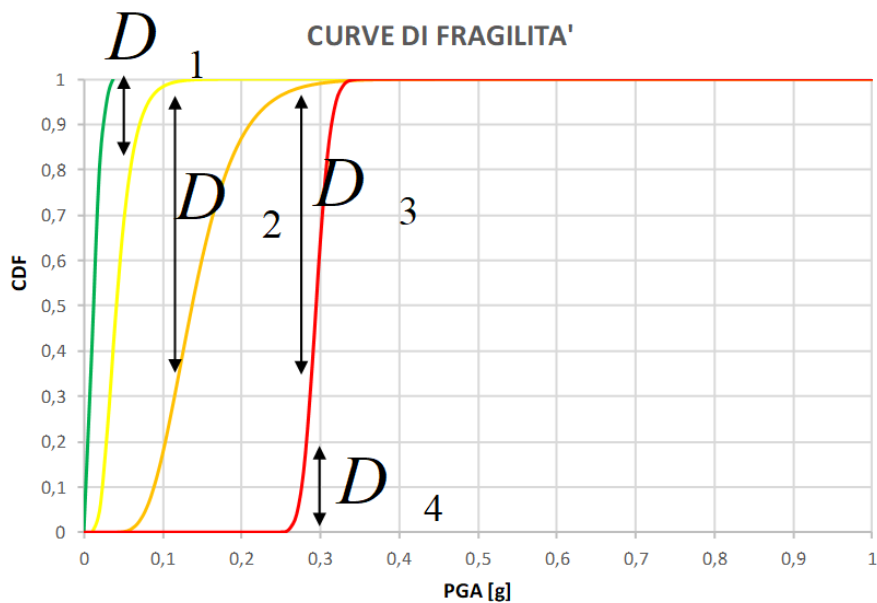
Figure 2.3.2: Fragility curves for Modena Cathedral corresponding to pre-intervention conditions.

$$P(pga) = \sum_i D_i(pga) \cdot Ds_i$$

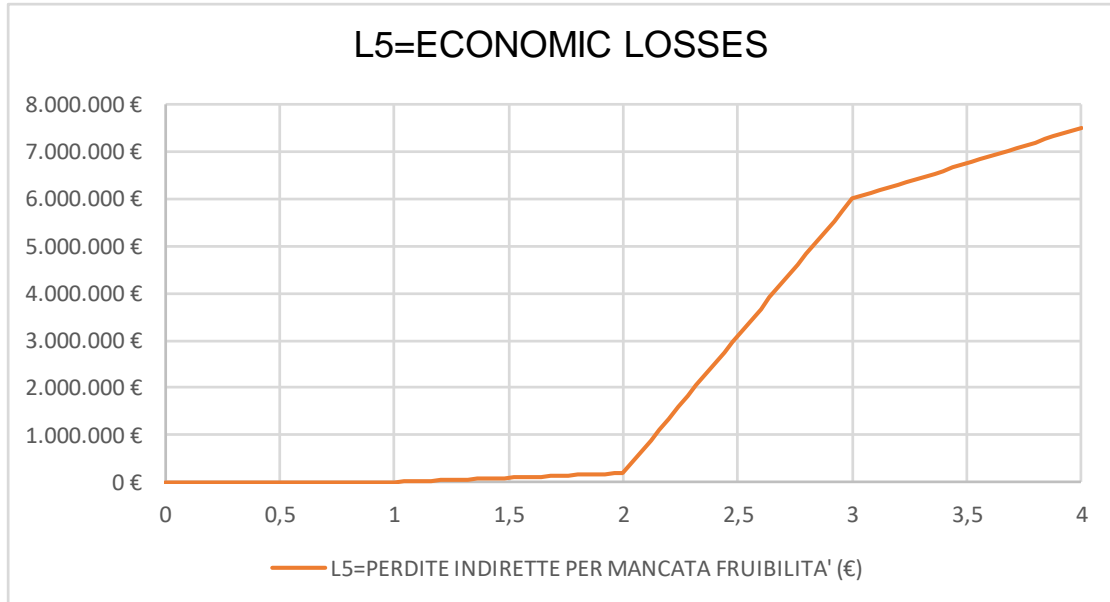
Figure 2.3.6: Vulnerability curve L5 for Modena Cathedral.

The following figure provides the vulnerability curve L5.

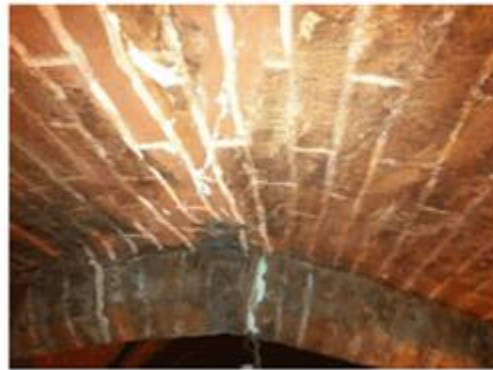
Figure 3.2.1: Consolidation of the decorated plaster with using compatible pigments

The extrados of the vaults will be consolidated by a removal of the existing layer and re-filling through injections of lime. At their intrados, there is a decorated plaster dating back to the beginning of the XX century, with false paintings bricks. The project includes the fill of the cracks with a compatible lime and the consolidation of the plaster with the use of pigments of the same colors (Figure 3.2.1). Furthermore, the reinforcement of the vaults will be also achieved by attenuating the discontinuities (through the extension of the “frenelli” and the insertion of “diatoni” bricks, Figure 3.2.2) and/or putting a 5cm-thick layer of lime added with eco-pozzolana and reinforced with carbon-fiber mesh (Figure 3.2.2).
