MiCHe project

Multi-risk Hazard\_ Norman Tower of  
Craco

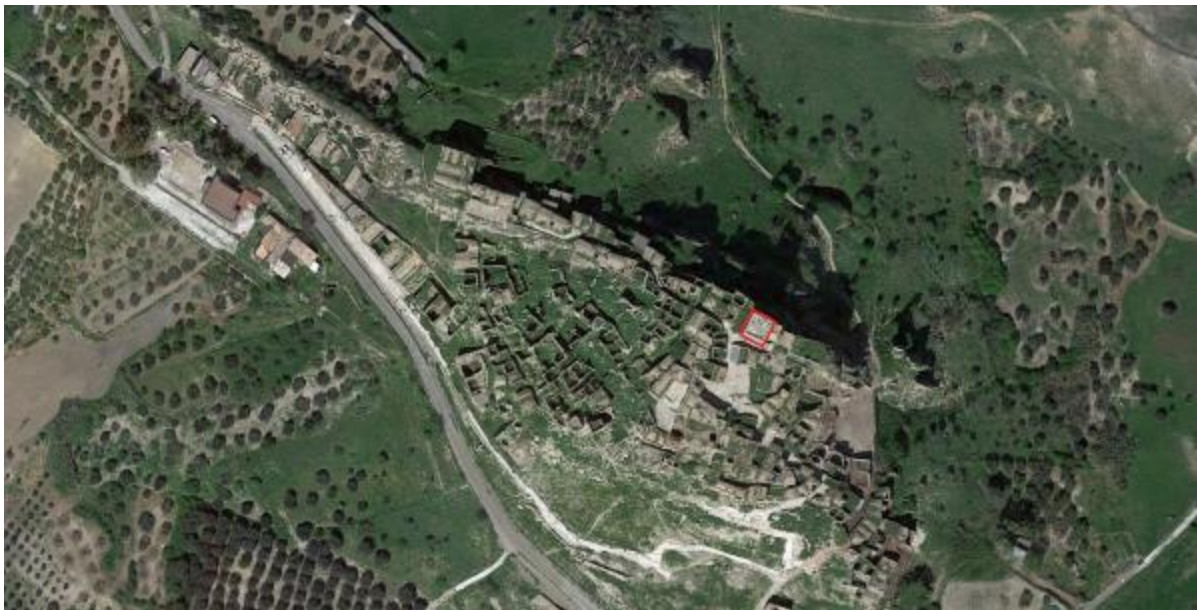
Today visiting Craco, the scenario is a village completely abandoned due to the damages at buildings caused by serious landslides developed in the south-western part between 1959 and 1972, as shown in Figure 1.

FIGURE 1: VIEW FROM THE TOP OF THE HISTORIC CENTRE OF CRACO, INDICATING THE NORMAN TOWER (IN RED)

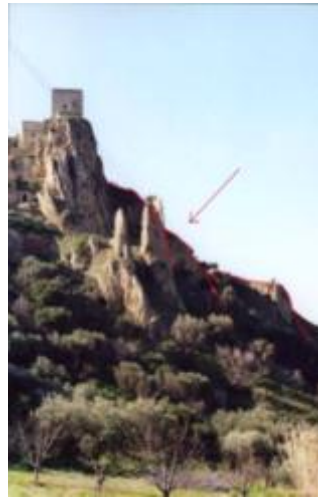
These phenomena mainly occur along the northern slope of the hills, where the steep conglomerate rock walls are located. In these areas local collapses can be observed that occur due to the state of fracturing of the cluster, of the alteration and erosion due to atmospheric agents. Isolated prisms of conglomerate are identified by the presence of structural discontinuities, and their stability is influenced by the laying conditions of these discontinuities with respect to the exposure and slope of the hill. The volumes of the observable unstable blocks are of modest dimensions, ranging from a few tens of cubic decimetres to, at most, a few cubic meters.

FIGURE 8 – DETACHMENT SURFACES OF COLLAPSES ALONG THE CONGLOMERATE WALLS OF THE NORTH-EASTERN SLOPE.

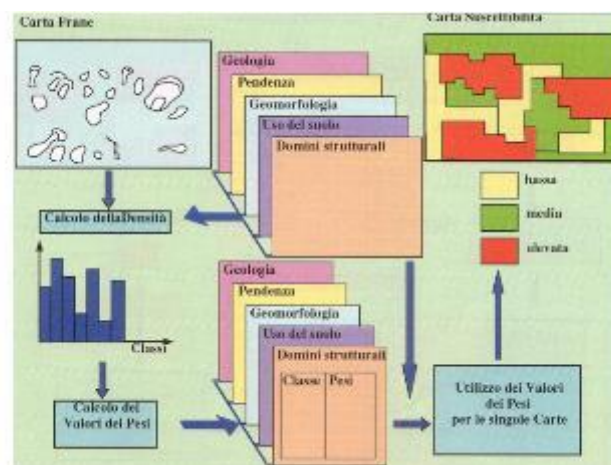
1. divide the area under examination into units, for example through a grid;
2. a weight is attributed to each of the factors mentioned above according to their relative importance as a cause of landslide;
3. a map of past landslides is constructed, to then be superimposed on the thematic maps of the single factors to identify the units in which landslides have already occurred and then carry out a statistical analysis;
4. each factor is subdivided into classes and a numerical evaluation is assigned to each class according to the areal frequency of the landslides;
5. the thematic maps of each factor are superimposed and, through a weighted sum operation, a numerical index representing the degree of danger is attributed to each unit of territory.

FIGURE 9 EXAMPLE OF EVALUATION OF THE DANGER OF AN AREA BY MEAN OF INDIRECT STATISTICAL METHODS (VAN WASTEN, 1996).

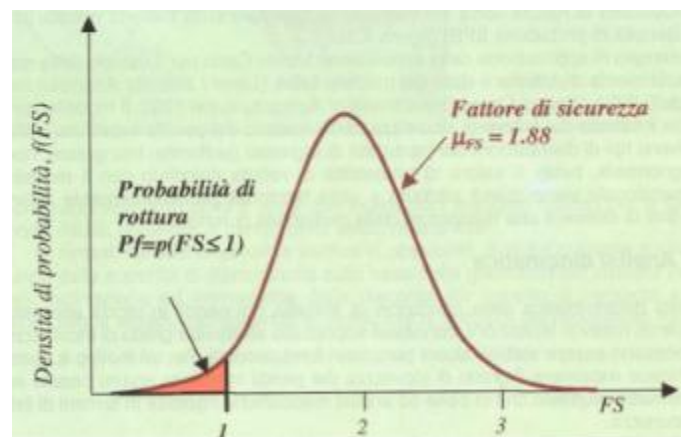
**Direct statistical approach:** it is based on the statistical analysis of cause-effect relationships between the triggering of a landslide and its causal factors; it consists, for example, of reconstructing the probability distribution of the safety factor  $F_s$  (using Monte Carlo simulations) as a function of the probability distribution of the various strength parameters, interstitial pressures, etc. and, therefore, calculate the probability of breaking as (Fig. 2):

FIGURE 10– EXAMPLE OF HAZARD EVALUATION  $D_1$  IN TERMS OF PROBABILITY OF FAILURE.

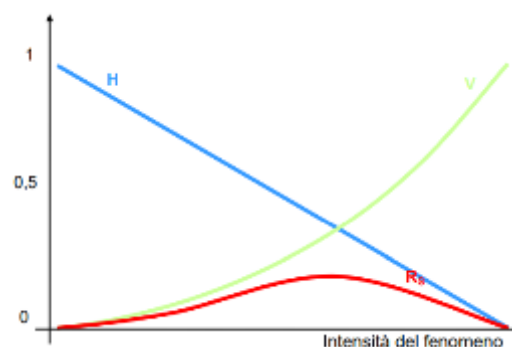
the risk will be higher where there is a high hazard in the presence of anthropic structures; vice versa, the risk tends to cancel itself out in areas characterized by low danger or low vulnerability (Fig. 16). The cartography thus obtained constitutes an important decision-making tool (Fig. 17) for the purposes of planning the territory (on a regional scale) and the planning of the interventions on the slope (slope scale). Since the choice of interventions is conditioned by various factors, often in contrast with one another (effectiveness, costs, environmental impact, etc.), it is suggested to use formalized methods such as, for example, the multicriteria analysis which, in addition to rationalizing and to make the decision-making process in question transparent, can help to identify the optimal alternative for the case in

FIGURE 16 EXAMPLE OF DANGER, VULNERABILITY AND SPECIFIC RISK TRENDS DEPENDING ON THE INTENSITY OF THE PHENOMENON (REGIONE LOMBARDIA, 2001).

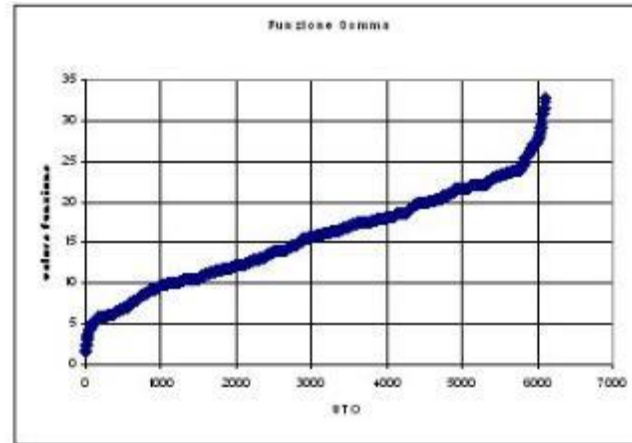
FIGURE 20 DISTRIBUTION OF THE SUSCEPTIBILITY VALUE CALCULATED WITH THE SUM FUNCTION FOR ALL UTOs [28]

In the case of the sum function, the distribution has two inflections, and a wide band in which the distribution is linear. It was initially decided to identify the separation values of the three susceptibility classes (high, average and low), corresponding to the inflections. On the basis of this choice it was found that the band relating to the class of average susceptibility was excessively wide, especially based on the distribution in the territory. This band has therefore been reduced by increasing the separation value between in low and average classes, choosing it equal to 15, and decreasing the separation value between the middle and high classes, choosing it equal to 20. In this way we obtained a map of susceptibility (Board5) closer to the characteristics of the territory in question.

In the two cases a distinct distribution of the final values attributed to the UTOs was obtained, as can be seen from the graphs of Figures 20 and 21.

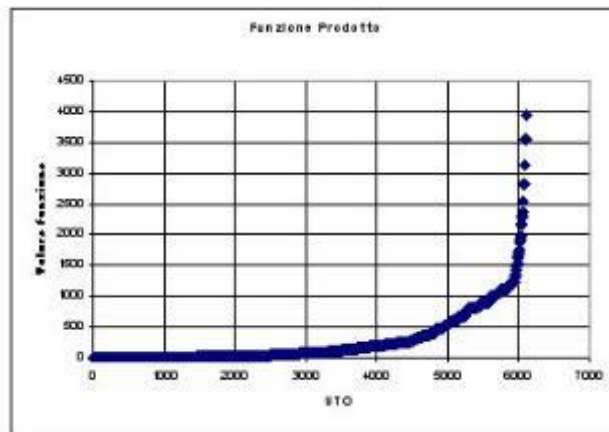
FIGURE 21 DISTRIBUTION OF THE SUSCEPTIBILITY VALUE CALCULATED WITH THE PRODUCT FUNCTION FOR ALL UTOs

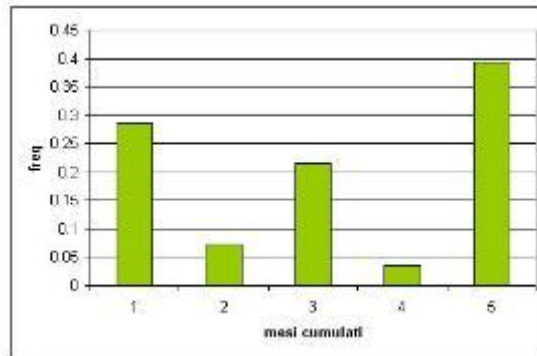
FIGURE 20 FREQUENCIES OF THE CUMULATIVE MULTI-MONTH PERIODS THAT RECORD THE MAXIMUM RETURN PERIOD; THE HIGH VALUES FOR THE ONE-MONTH CUMULATIVE REFER TO THE FLOOD EVENTS OF 1959 AND 1972 [28]

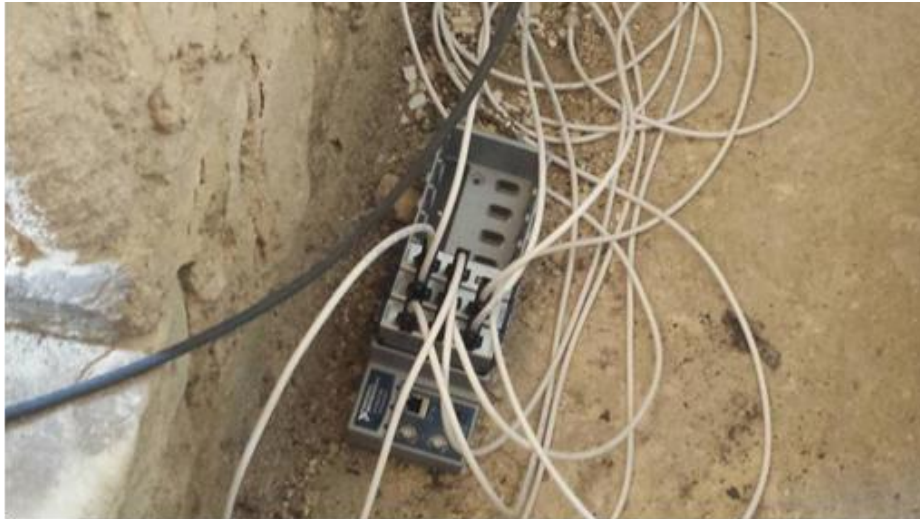
FIGURE 29 – CHASSIS MODULE NI9188 WITH 8 SLOTS FOR DAQ CARD.

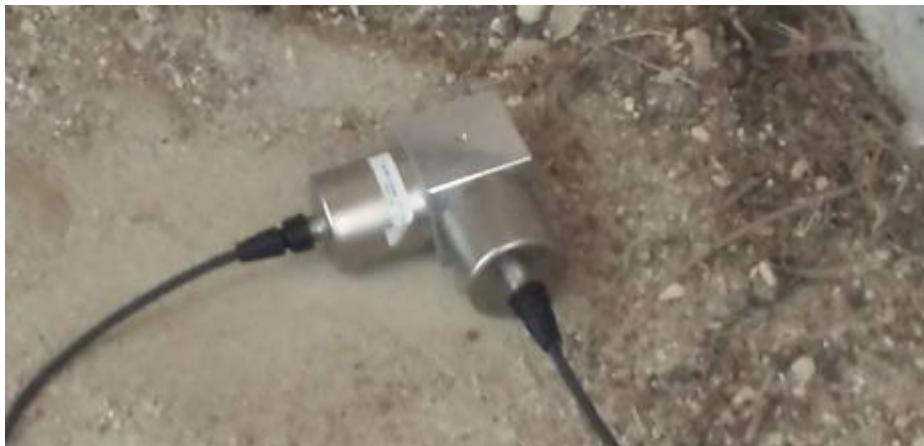
FIGURE 30 PIEZOELECTRIC ACCELEROMETERS PBC OF THE NATIONAL INSTRUMENTS, ORTHOGONAL BETWEEN THEM.

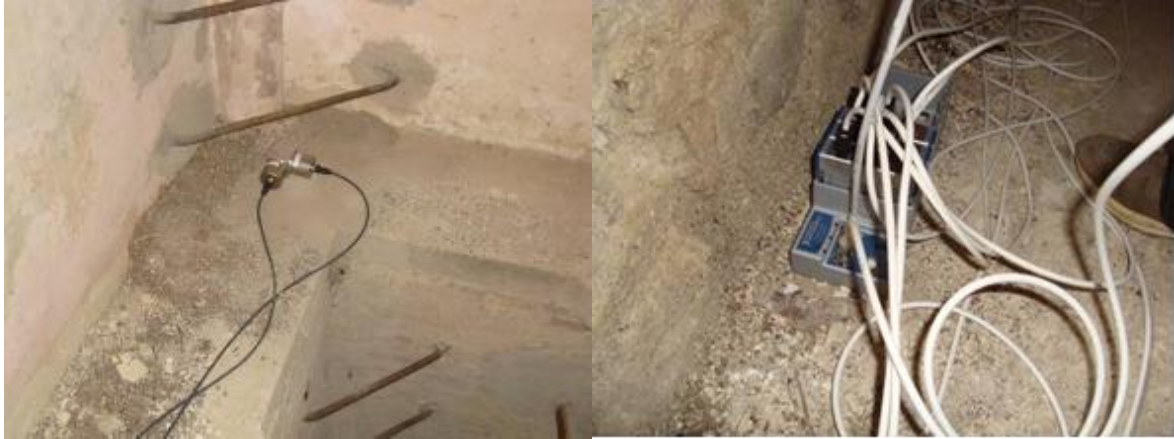
FIGURE 33 PIEZOELECTRIC ACCELEROMETERS POSITIONED AT THE SOUTH-WEST CORNER OF THE TOWER AT 12.5M

FIGURE 34 DAQ 1 (DATA ACQUISITION MODULE) LOCATED AT 12.5 M.

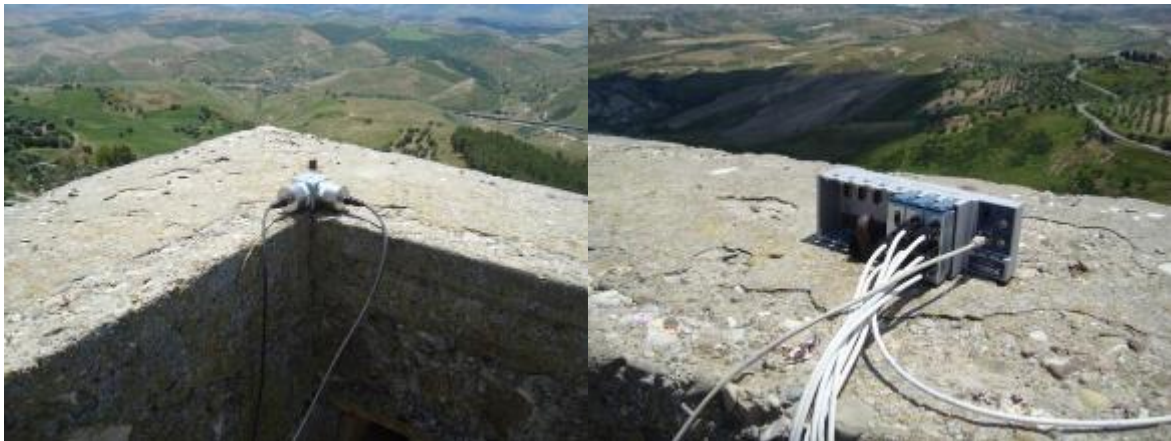
FIGURE 35 PIEZOELECTRIC ACCELEROMETERS POSITIONED AT THE SOUTH-EAST CORNER OF THE TOWER ROOF AT A QUOTE OF 21 M

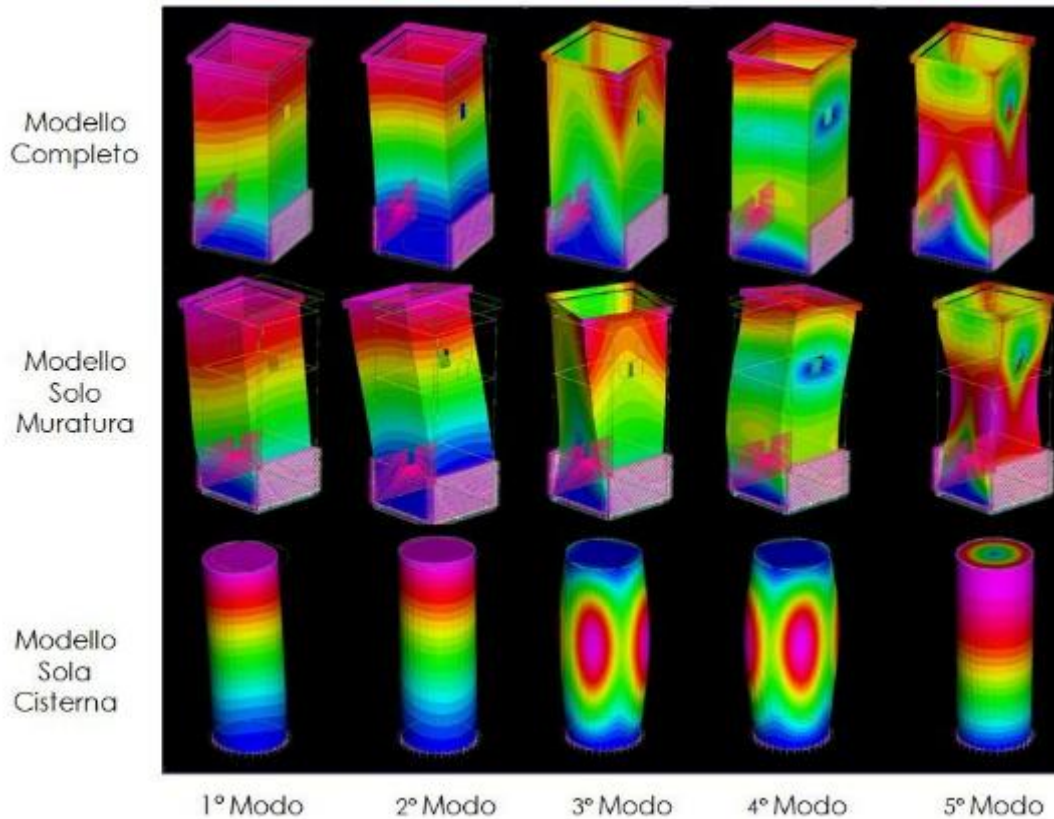
FIGURE 49. FIRST FIVE MODES OF VIBRATING OBTAINED FROM THE NUMERICAL ANALYSIS OF THE THREE DIFFERENT MODELS CONSIDERED.

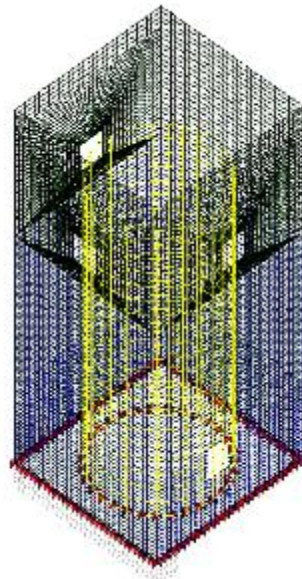
FIGURE 66—PROSAP FE-MODEL OF THE TOWER WITH IMPOSED VERTICAL DISPLACEMENT
