MICHe: CASE STUDY UNIBO-MODENA CATHEDRAL

MICHE: CASE STUDY UNIBO-MODENA CATHEDRAL	1
Introduction	5
PART 1: GUIDELINES	7
1 Introduction	7
1 Guidelines for the integrated knowledge of cultural heritage assets	9
2 Guidelines for Multi- Analysis Integrated Assessment and weaknesses identification	10
3 Atlas of structural solutions for the conservation of cultural heritage buildings	11
PART 2: CASE STUDY- THE MODENA CATHEDRAL	12
CATHEDRAL OF MODENA: THE INTEGRATED KNOWLEDGE	12
1 THE CATHEDRAL OF MODENA	12

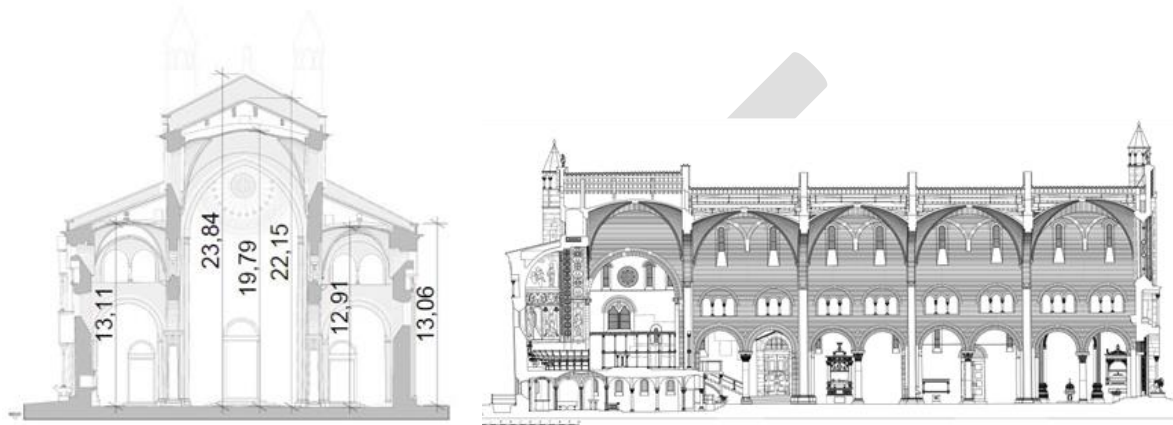
Figure 5: Cross-section of the Cathedral of Modena

nave and the side aisles have four spans. The vaults of the central nave have double length span with respect to the length span of the vaults of the aisles. The maximum height of the vaults of the central nave is around 20 m, while that of the side aisles is approximately 13 m. Next to the Cathedral, there is the Ghirlandina Tower, a high tower of roughly 88 m high whose construction proceeded in parallel with that of the Cathedral up to the fourth level. The upper part of the Tower was built later, between 1261 and 1319 [7].

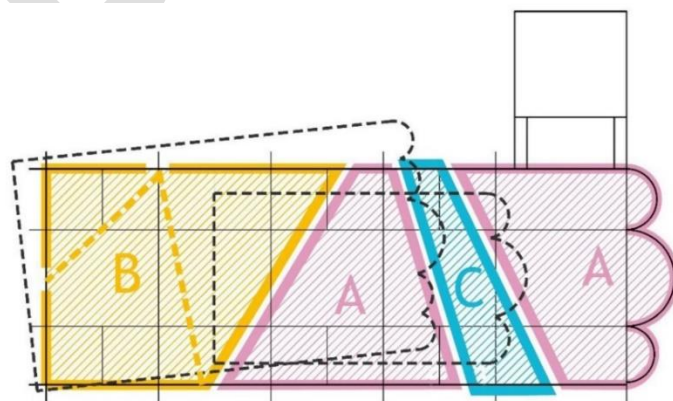
Figure 7: The construction phases

There is an open debate about the construction phases leading to the actual fabric [10], [11], [12], [13],[14]. According to the hypothesis of Porter [15], confirmed later by other researchers, the construction began in 1099, almost in parallel, from the apses and, just few years later, from the main façade. At 1130, the complex knew the construction of the clerestory and the joining of the lateral naves where, according to Peroni (1989 and 1999) and Lomartire (1989), the initial construction was interrupted in order to maintain the portions of the pre-existing Cathedral. More recent historical studies [14] suggest that the construction of the outer perimeter did not proceed in parallel from the two sides, specifically the main façade and the apses, but started from the apses (phases A) to end with the main façade (phases B), (Figure 7: The construction phases). In light of this alternative hypothesis, the phase C was remarked by the repair of some damages due to early soil settlements manifested during the first two phases. This reconstruction may be further supported by the analysis of the cracking pattern. Figure 7 graphically represents the three construction phases according to this last hypothesis.

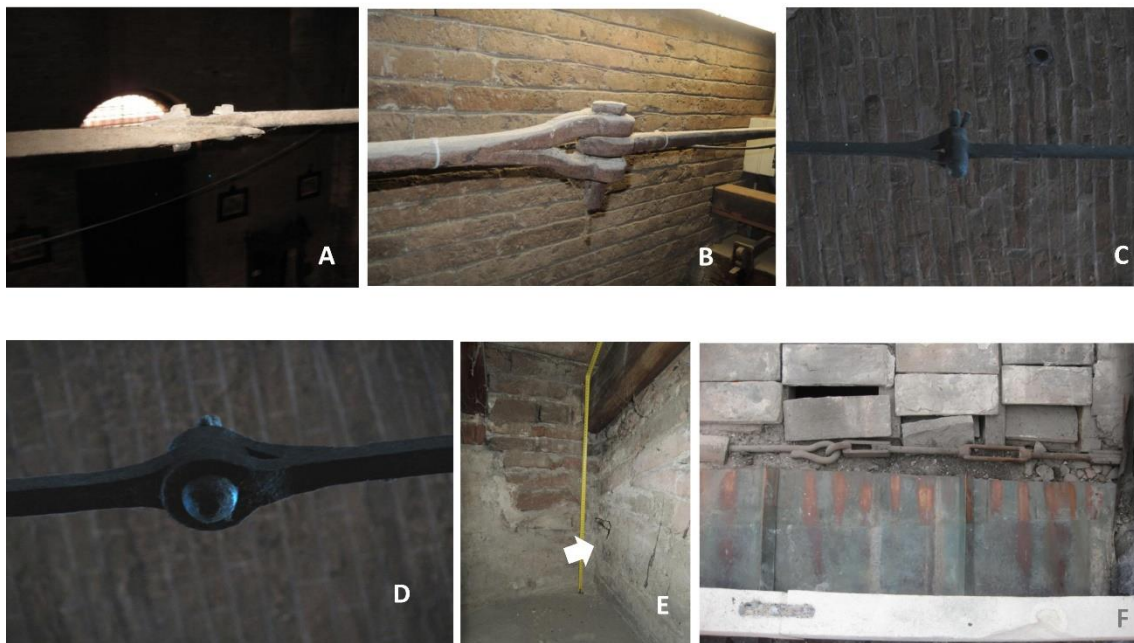
Figure 8: Survey of the tie-rods installed on the Cathedral during the years and respective photographers.

After the end of the construction, several interventions were carried out during the years. The elevation of the Tower in the following years caused the lowering and slight rotation of the apses due to differential soil settlements. The presbytery appeared so slanted that it was necessary to realize many reparations and reconstructions according to a new verticality and horizontality. This was one of the principal intents of the architectural renovation applied by the Campionesi masters at the Cathedral of Modena during the years 1180-1220. In the light of the studies on the construction phases, the 3D laser scanner survey was able to measure the different inclinations of the masonry walls belonging to the different phases, thus dating the successive increases of the foundation settlements along the centuries. According to several historians, the original roof system, made of timber trusses (“capriate”) arranged in the transversal direction, was rebuilt after 1413. The orientation of the principal beams was changed when the vaults of the naves were constructed. Probably during this phase, the original timber beams were replaced causing deformations of the longitudinal walls. Later on, other interventions proved to be necessary after the earthquake events occurred in the 1501, 1505 1671 and 1832. The main interventions affected the vaults, the arches, the façade and the portions of walls adjacent to the Ghirlandina Tower [16]. In the following years, additional strengthening interventions were performed, such as refilling the main cracks, repairing the roof (new wood structures connected to the masonry wall by iron chains) and connecting the walls through iron chains in the naves at different heights (Figure 8). At the beginning of the XX century, all the constructions built next and into the Cathedral during the years (rectory, cluster, sacristy and internal chapels) were demolished in order to restore the original Romanesque aspect. In 1975, Modena and its Cathedral were affected by the soil subsidence. During the recent years, starting from the 2006, a restoration campaign has interested the external stone facade, until the earthquakes of the 2012 shifted the attention to the damages of the interior, principally the vaults, as it will be better explained in § 3.4.

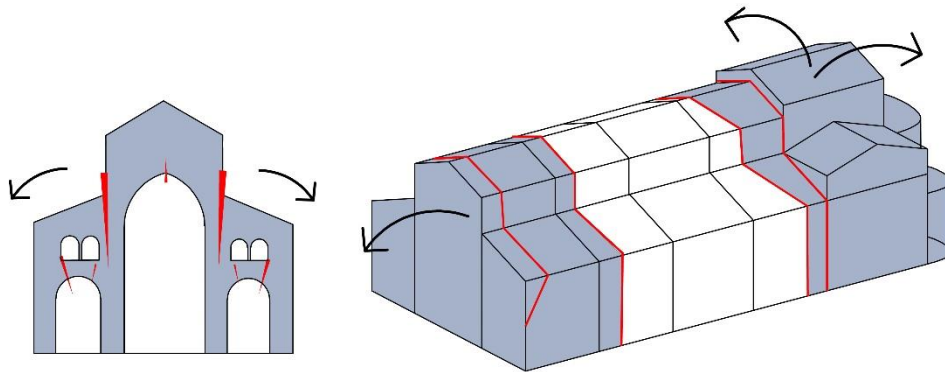
Figure 11: (a) Crack pattern of the Cathedral of Modena and (b) main failure mechanisms of the Cathedral on the longitudinal and transverse direction

The initial crack pattern (2010) has been studied not only to monitor the state of the main cracks but also to correlate their location within the construction phases and main interventions. The analyses of past studies also helped in the classification of the cracks. In particular, the correlation between the damage and the past interventions allow to identify the probable causes and distinguish between stable cracks and still evolutionary situation. The major cracks are displayed in Figure 11. The main cracks are indicated in red, while grey areas indicates the zones of diffused cracks with potential high vulnerabilities. It can be noted that:

- a large vertical crack is located in the main facade, just below the big rose window;
- a concentration of cracks has been identified in the connection between the walls, all along the portion of the building constructed during the phase C, in the fourth span from the west;
- another cracks concentration appears near the main facade, along a line parallel to the façade, in the second span from the west;
- vertical cracks along the main transversal walls and arches separate the central naves from the lateral naves.

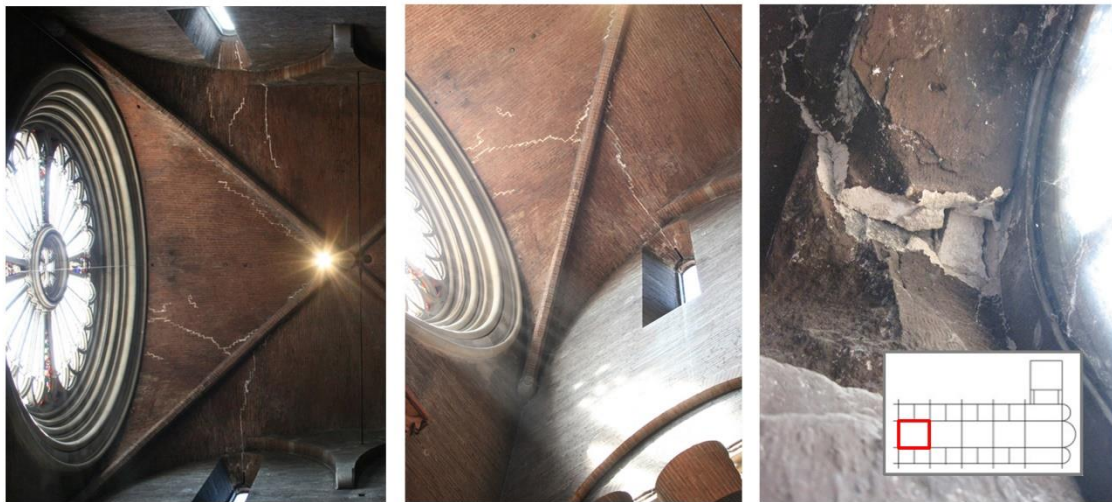
MAPS OF THE CRAKS DETECTED ON THE VAULTS-earthquakes of the 20, 29 may 2012 and 21 June 2013

Figure 12: (a) Maps of the cracks detected on the vaults after the earthquakes of the 20 and 29 May 2012 and 21 June 2013 and comparison with the crack pattern and (b) photographs on the damage caused by recent earthquakes.

The grey areas are mainly located in the portion of the Cathedral coinciding with the location of the old Cathedrals. During the survey after the 2012 Emilia Earthquakes, new cracks appeared in the intrados of the main vaults. Moreover, an evolution of some existing cracks has been also observed (Figure 12).

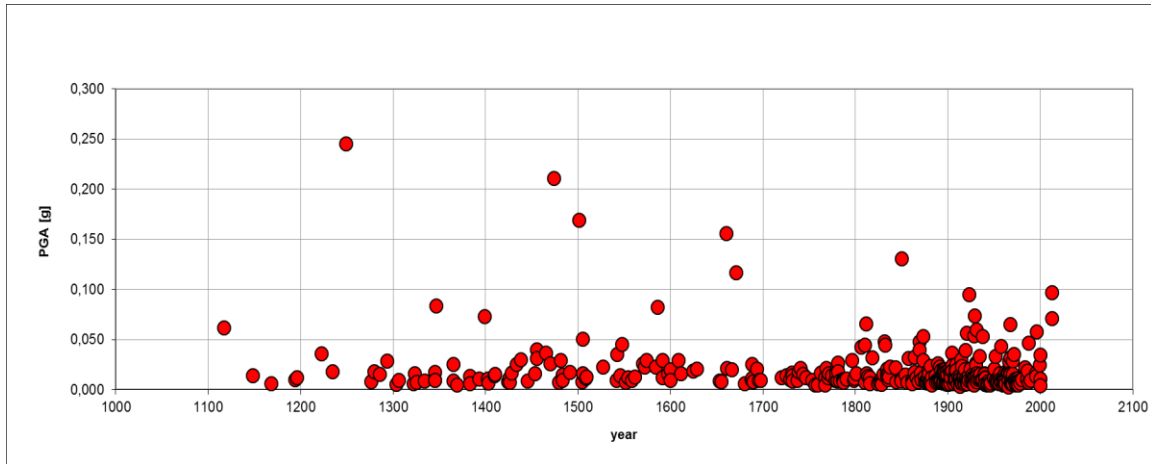
Figure 13: Reconstruction of the median of the PGA, obtained considering the epistemic uncertainty associated to the Sabetta-Pugliese ground motion prediction model, for all earthquakes of the CPTI04 earthquake catalogue.

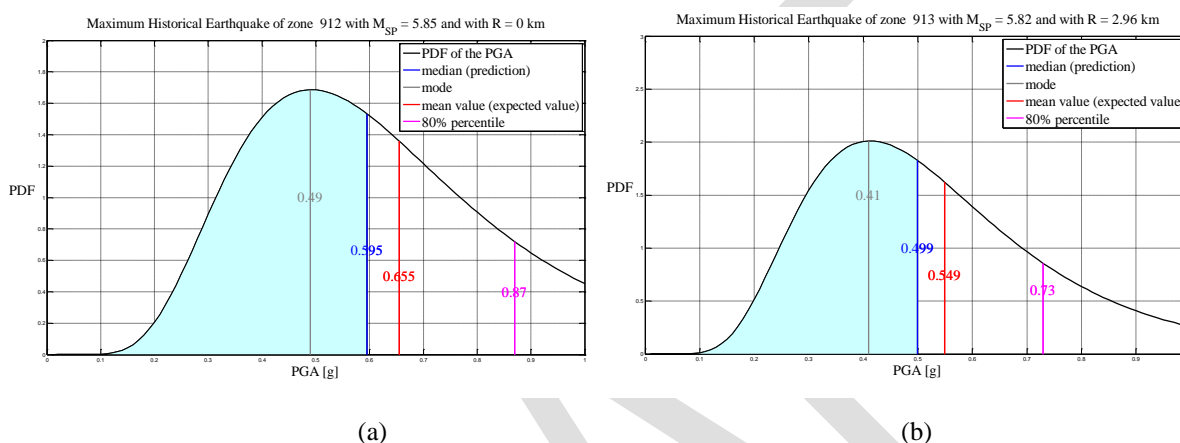
Figure 14: Probability density function (PDF) of the PGA in the site of the Cathedral of Modena as a result of seismic activity of zones: (a) zone 912, (b) zone 913.

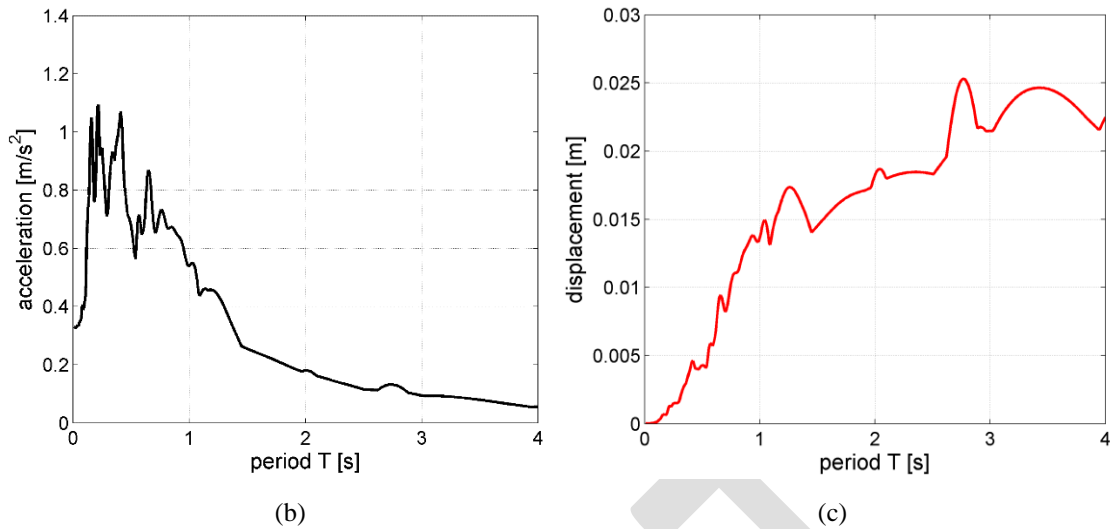
Figure 16: (a) The acceleration recorded by the station MDN during the main shock of 20th May 2012, (b) the corresponding spectral acceleration and (c) the corresponding spectral displacement

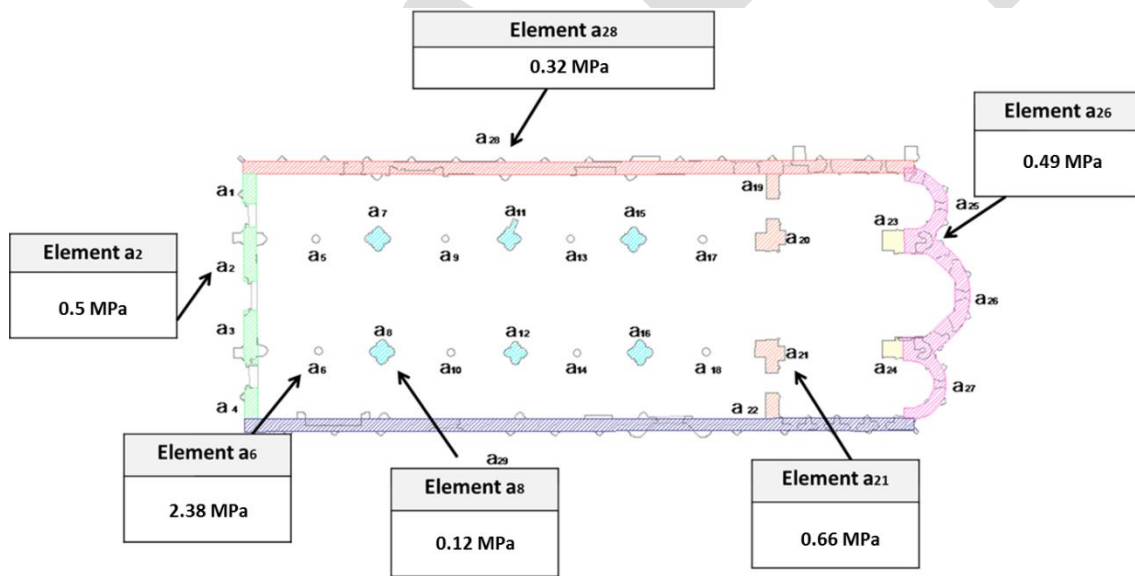
Figure 20: Reference values of the stress level at the base of the principal structural elements.

The hand-made schematizations of the single walls are used to calculate the stresses at the wall base, according to the Navier - de Saint Venant formulation, due to the self-weight, the weight of the vaults and the reactions of the roof system. In detail, the following assumptions have been made: (i) two limiting conditions: full cross-section and hollow cross-section (or “a sacco”, i.e. two exterior masonry layers plus an interior layer composed of chaotic stones and filling materials; in the “a-

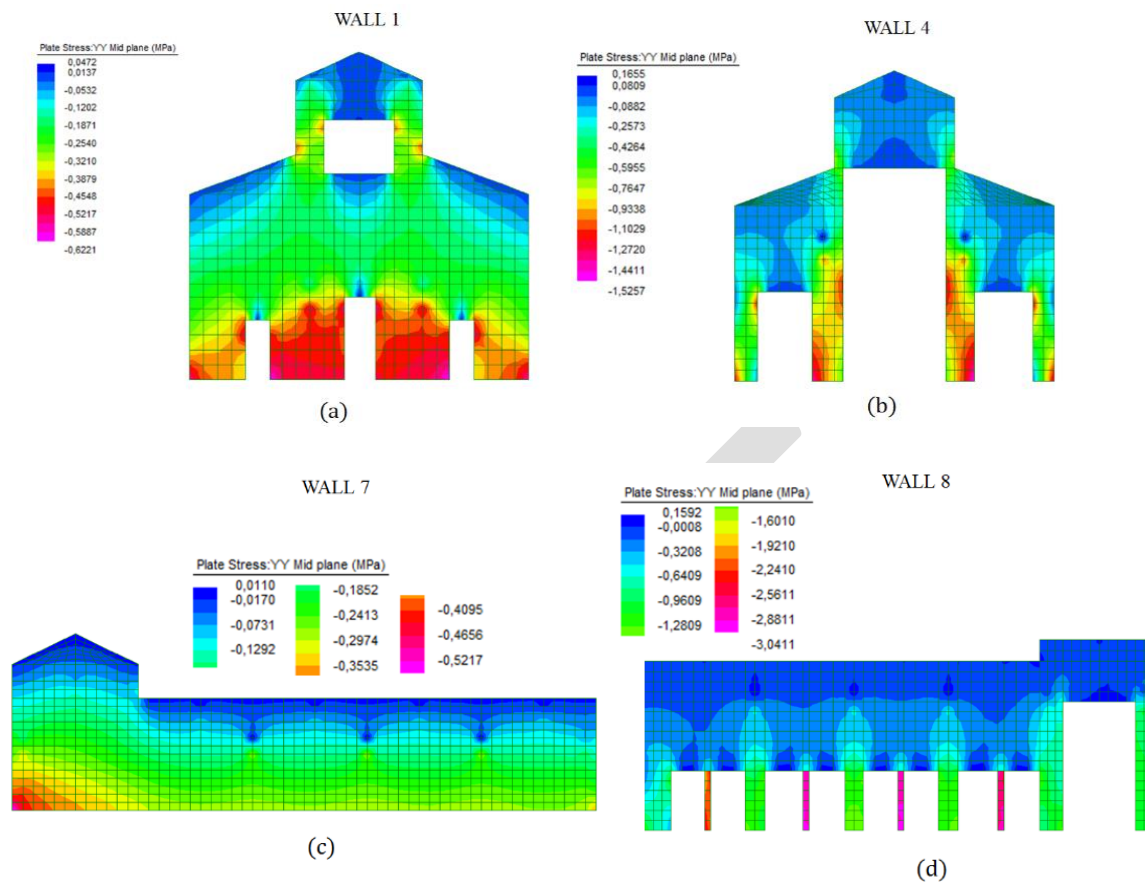
Figure 21: Contour maps of the normal stresses at the base of some walls obtained with two-dimensional FE models: (a) Wall 1; (b) Wall 4; (c) Wall 7; (d) Wall 8;

sacco" configuration the wall inertia is equal to the inertia of the two exterior layers only); (ii) constant wall thickness equal to the average wall thickness; (iii) the presence of decorative elements has been neglected; (iv) each wall has been subdivided into homogeneous portions (i.e. same cross-section, referred to as a_i , $i=1, \dots, 28$) for the evaluation of the normal average stresses at the base, (iv) perfect verticality of the masonry walls. In the limiting case of full cross-section, the normal stresses due to the gravity loads are between 0.3 and 0.8 MPa for exterior walls and between 1 and 1.4 MPa for masonry piers. On the other hand, in the limiting case of hollow cross-section ("a sacco" masonry), the normal stresses due to the gravity loads double both for the external walls and the internal piers. The maximum stress at the base of the stone columns is around 3.2 MPa. The increase due to the snow load is about 2.5% of the stresses due to gravity load. These stresses levels at the walls base obtained from simple hand-made models (Figure 20) have then been compared with those obtained from the 2D FE models, which are reported in terms of contour maps in Figure 21. This comparison indicates a good agreement between the two analyses.

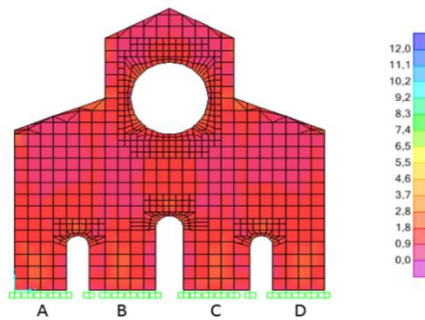
Figure 32: Tangential stresses

Figure 32 shows the tangential stresses calculated for wall 1 and Table 5 - Verification of the shear strength for the wall 1 reports the values obtained for the sliding check. Figure 33: Sliding check for all the walls of the cathedral: (a) transversal walls and (b) longitudinal walls summarizes the results obtained for all the walls of the cathedral and highlights that the greatest criticalities are related to the in the internal transversal walls.

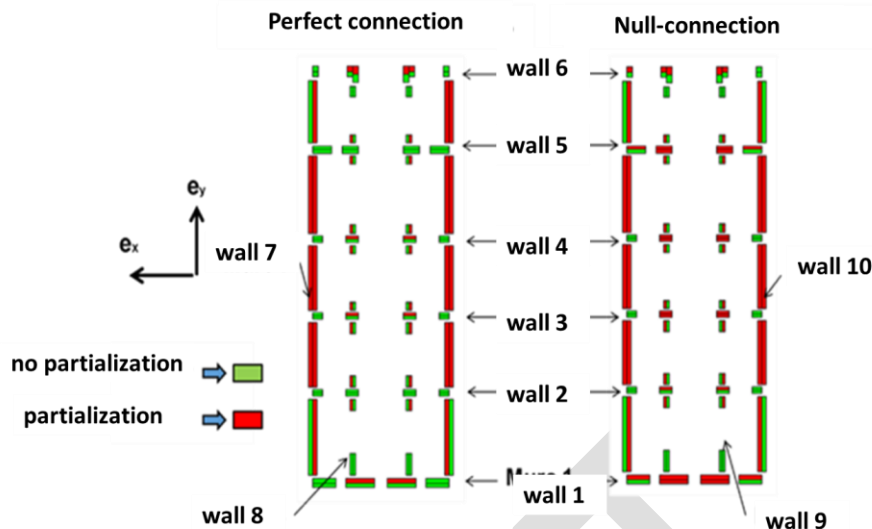
Figure 36: Vulnerability for the out-of-plane mechanisms in the walls

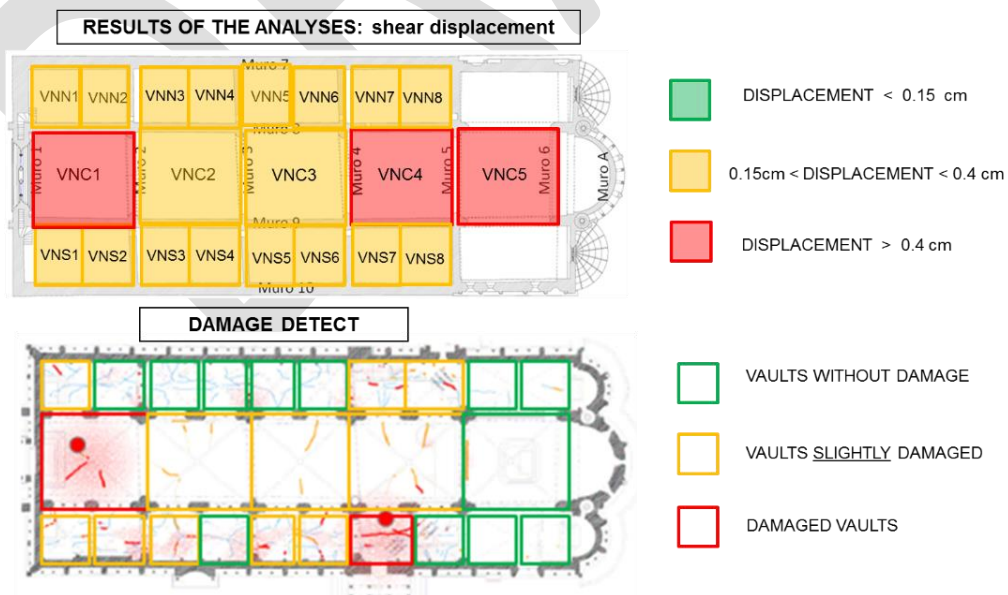
Figure 38: The comparison between the shear displacements and the damage detected on the vaults after the 2012 earthquake

The results obtained in terms of shear displacement are compared with the survey of the damage observed after the 2012 earthquakes (Figure 38). It can be noticed that generally the vaults mainly damaged correspond at the vaults that suffered the major shear displacement at the springings due to the vibration of the underneath walls and piers.

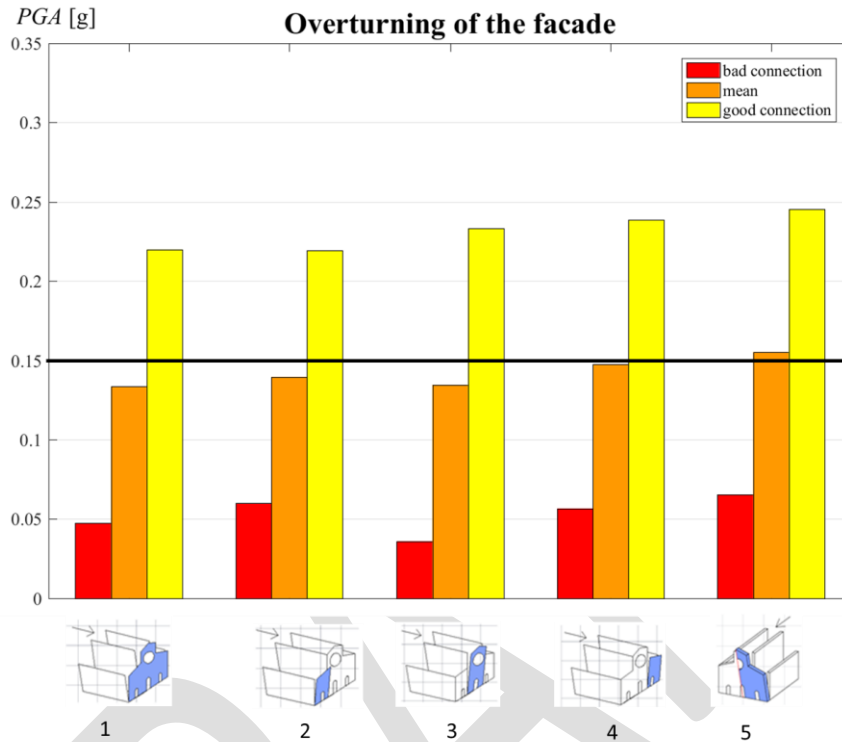
Figure 40: Comparison between the accelerations that activate the 4 mechanisms of collapse for the façade

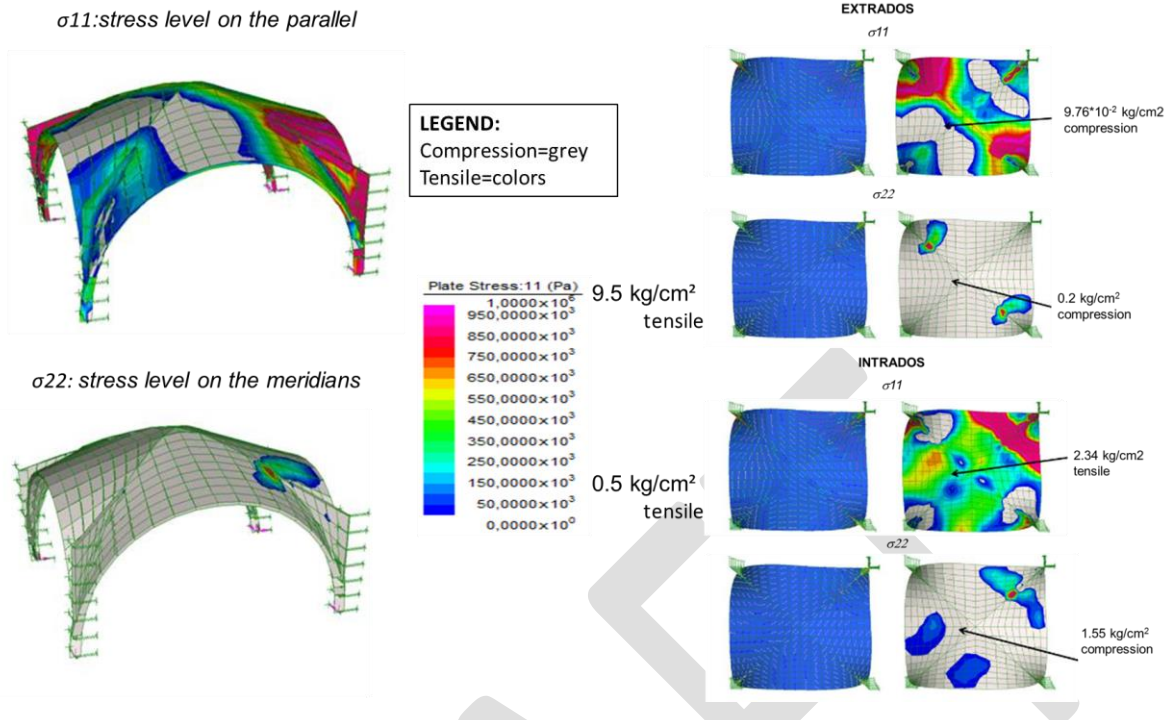
Figure 43: Stress levels of the vault VNC1 obtained from the static analyses considering the considering self- weight and the shear imposed displacements

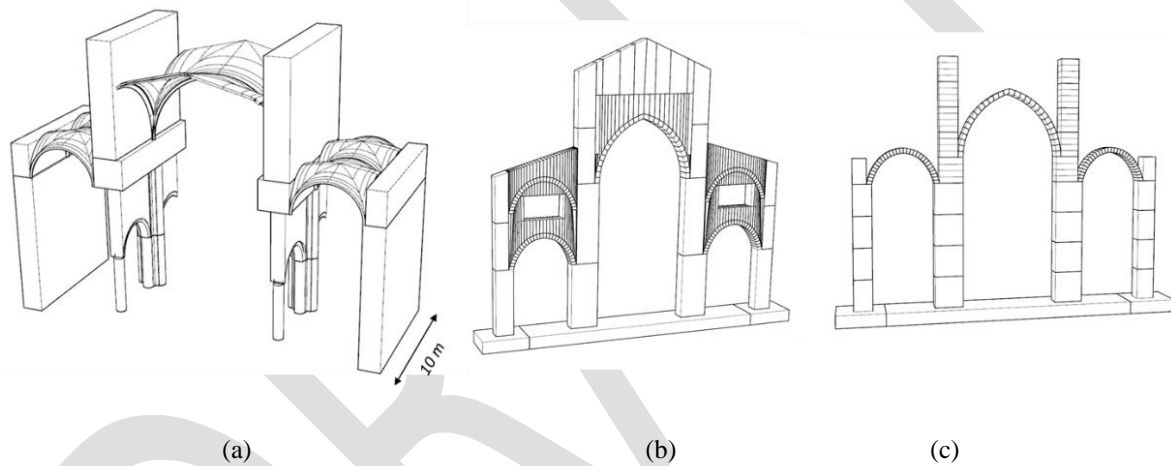
Figure 48: (a) The investigated cross-section of the Cathedral of Modena: representation of the structural elements, (b) the “COMPLETE DEM”, (c) the “SIMPLIFIED DEM”

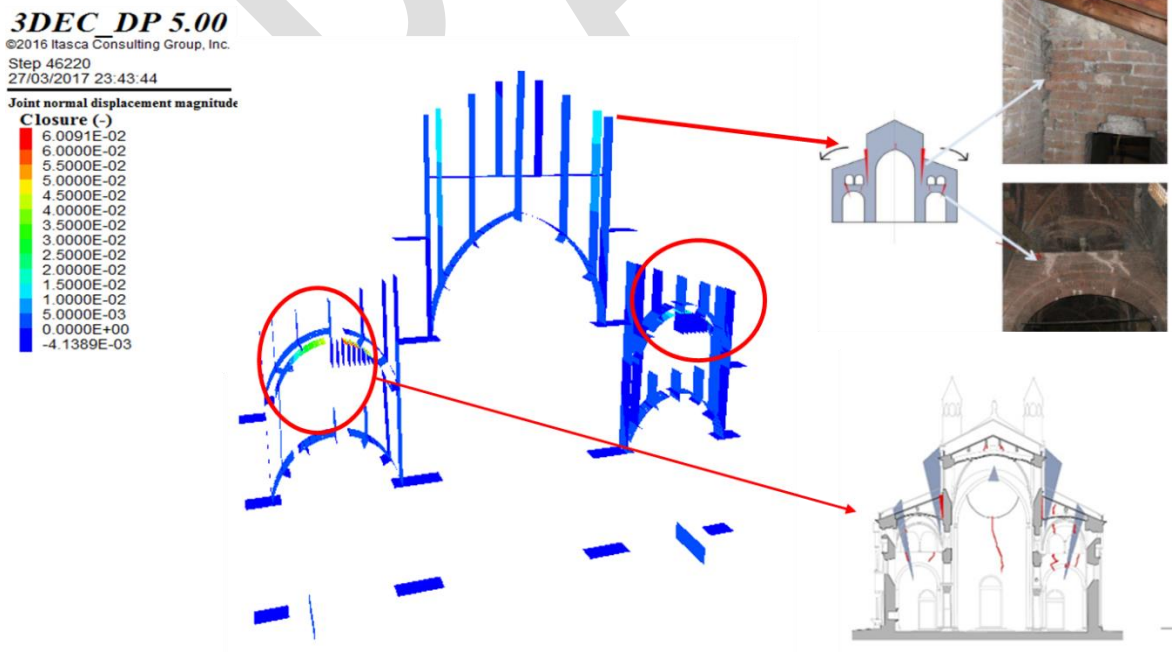
Figure 52: Contour plot of the interfaces of the COMPLETE DEM model and the crack pattern detected in the 2010

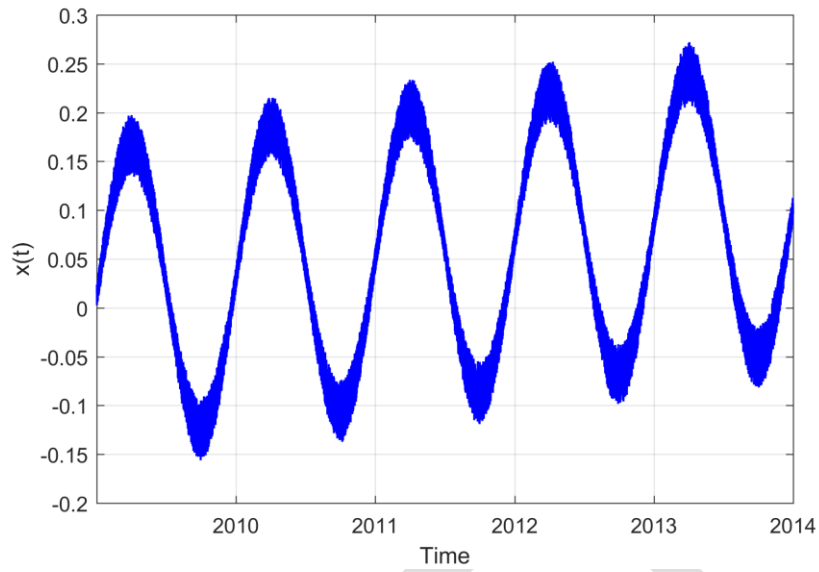
Figure 54- Time series $x(t)$

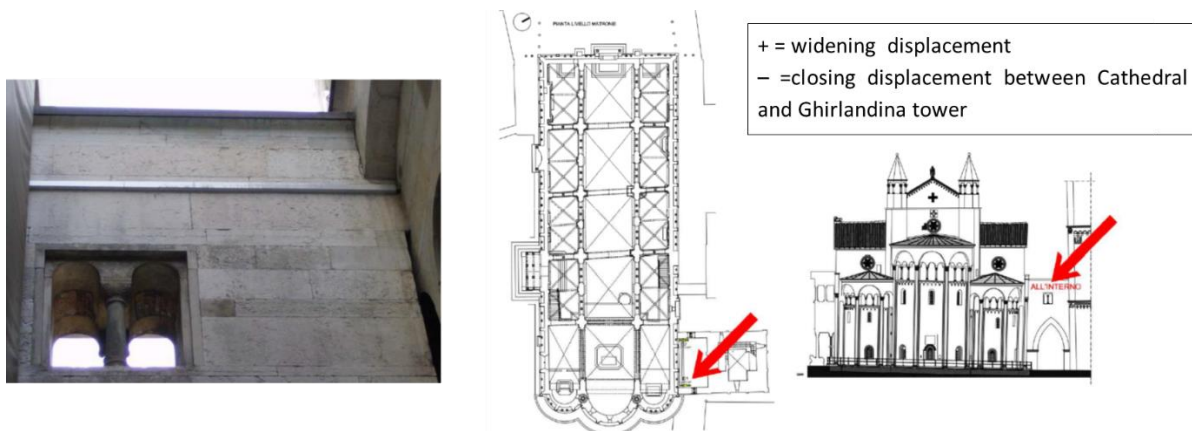
Figure 57: Deformometer installed on the buttress of the Cathedral (D1)
Table 19- Technical specification of the Invar Deformeters

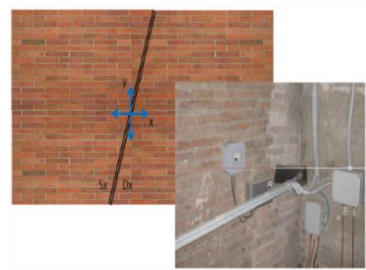
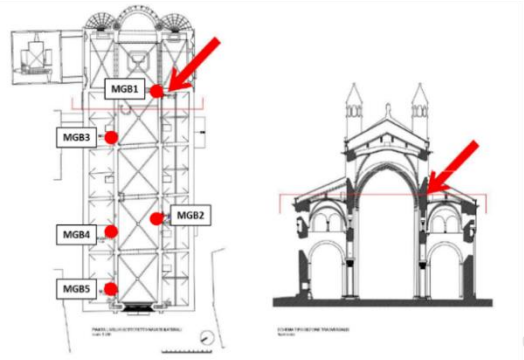
Figure 58: Biaxial joint meter installed in the central nave of the Cathedral (MGB1)

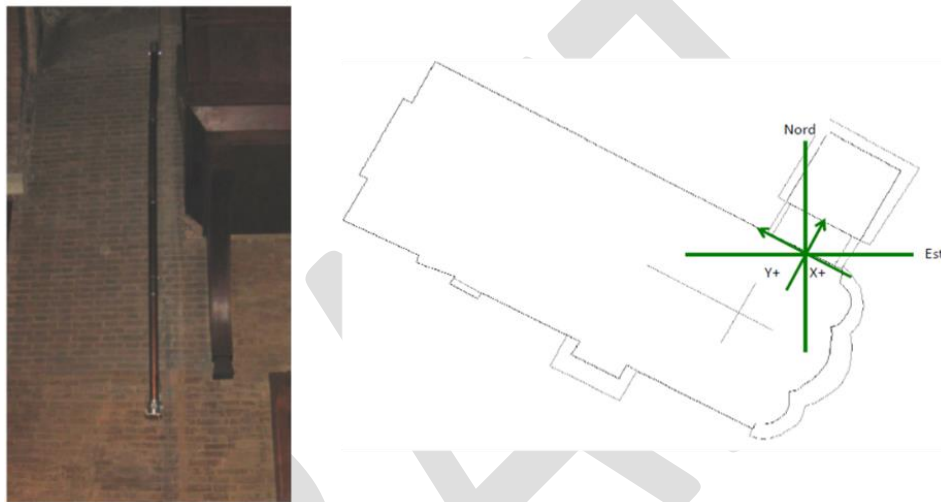
Figure 60: Inclinometer installed on the longitudinal wall of the cathedral (close to the buttress) FP1 and the conventional signs used.

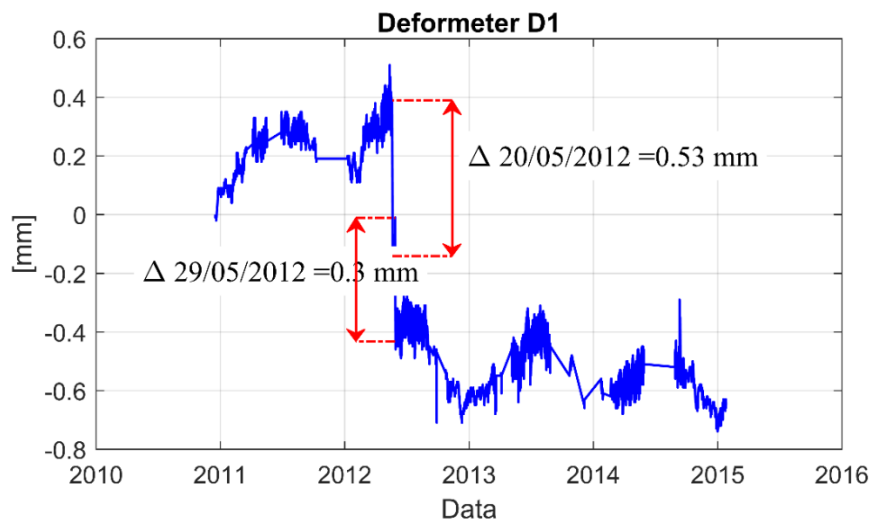
Figure 61: Data recorded by the deformer D1 installed on the buttresses between the Cathedral and the Ghirlandina Tower

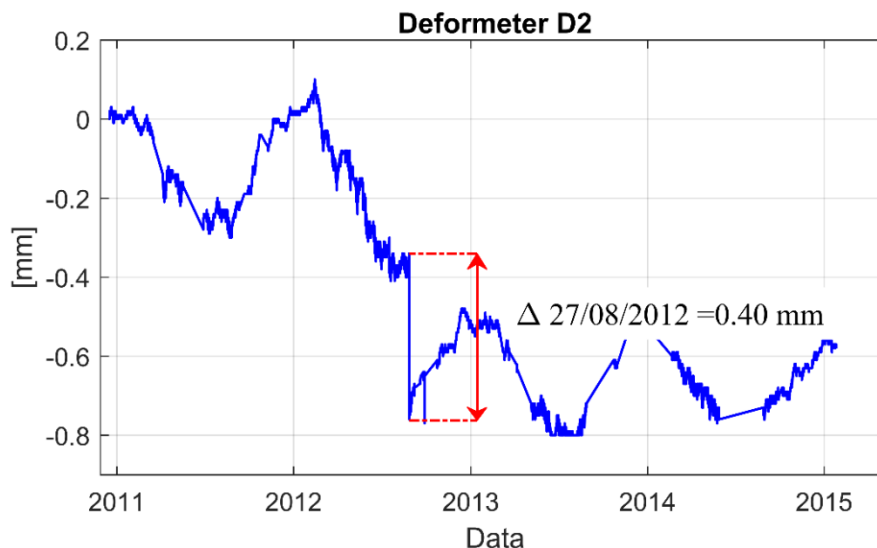
Figure 62: Data recorded by the deformer D2 installed on the buttresses between the Cathedral and the Ghirlandina Tower

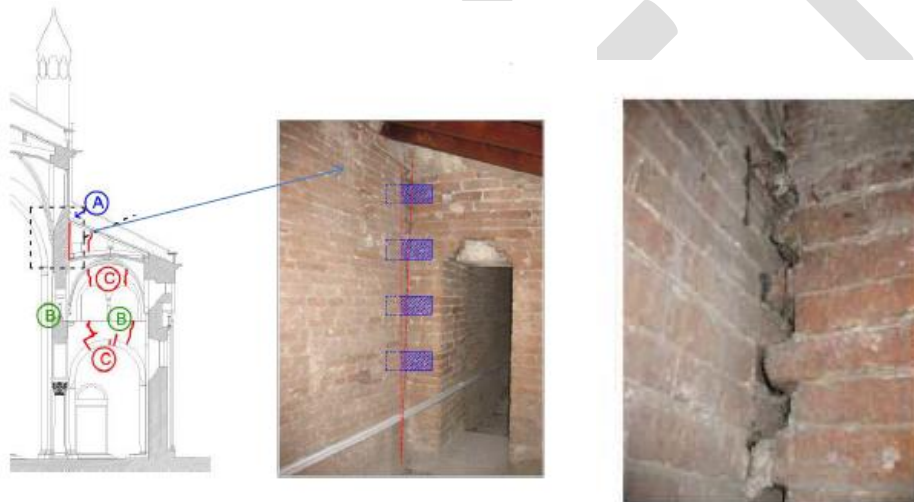
Figure 75: Connection of the orthogonal walls

In order to ensure a box behaviour, an important concept to increase the seismic behaviour of the Cathedral, the connections between the orthogonal walls will be improved through insertions of new diatons and injections of compatible lime.

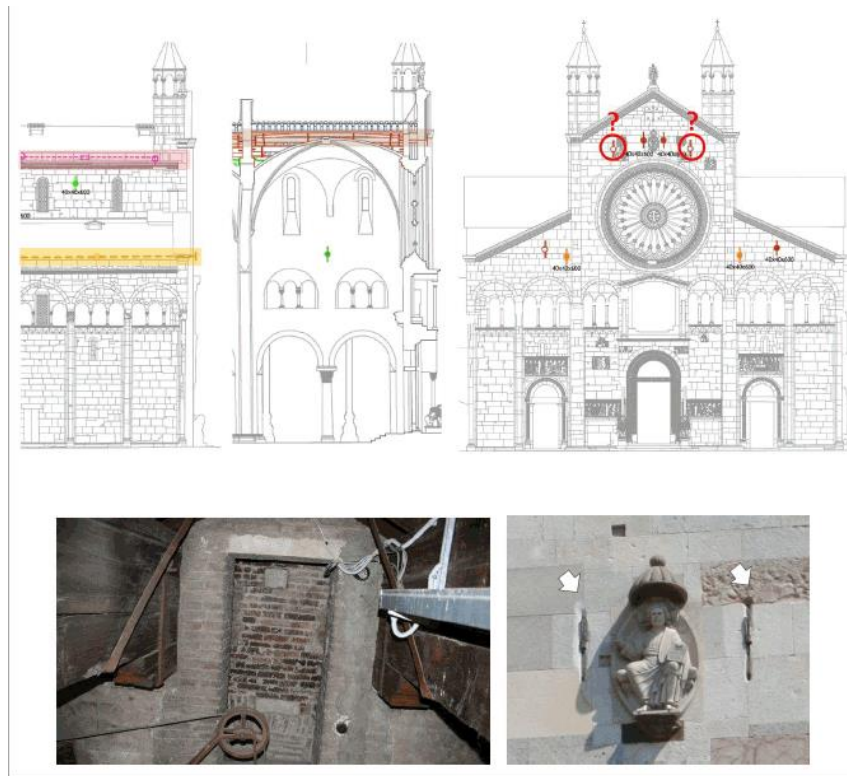
Figure 76: Reactivation of the existing tie-rod and plate anchors to contrast the overturning of the facade

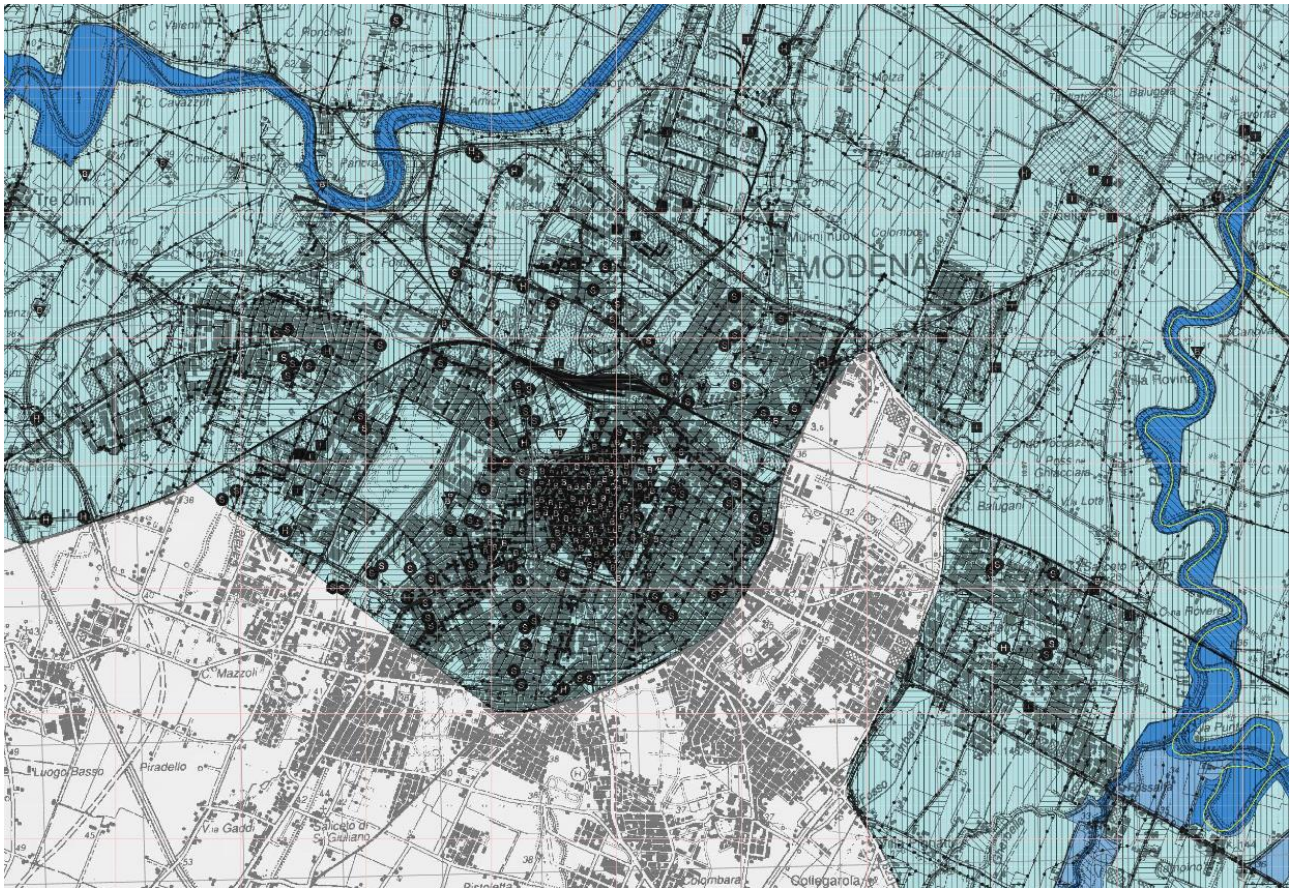
Figure 78 – Flood hazard map for the city of Modena.
